FOULED BALLAST AND GEOTECHNICAL ASSET
MANAGEMENT OF RETAINING WALLS

A thesis submitted to the Graduate Council of
Texas State University in partial fulfillment
of the requirements for the degree of
Master of Science
with a Major in Engineering
December 2022

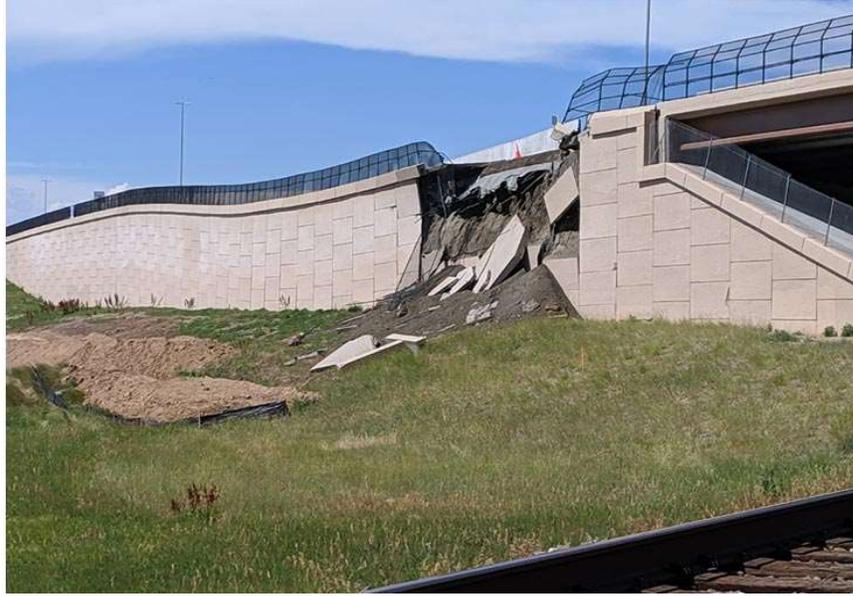
While failure is uncommon, the economic impact of a single MSE wall failure can be in the millions. A recent MSE wall failure can be seen in Figure 1-2, costing Colorado DOT \$20.5 million in repairs (Shaw, 2019). The investigation concluded that the failure was attributed to heavy rains during construction, and poor drainage (Minor, 2021). A contractor completed repairs to the failed section of the wall shown in Figure 1-2 within six months. The most frequent problems associated with MSE walls are loss of backfill, settlement, and drainage (Tarawneh, Al Bodour, & Masada, 2018). These problems can be identified by DOTs before there is considerable damage so that failures like the Colorado example can be avoided with a GAM program and routine inspection of the MSE wall.

Figure 1-2 Colorado U.S. 36 Bridge MSE Wall Collapse (Shaw, 2019)

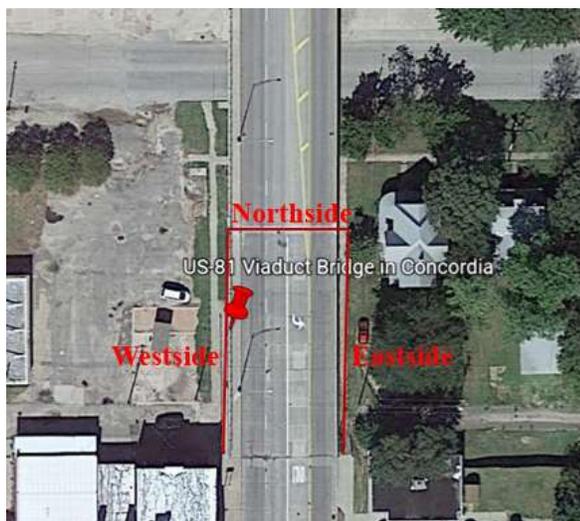
Figure 4-7 US-81 Over Railroad MSE wall

An onsite inspection in March 2022 was conducted on the US-81 over Railroad MSE wall. The complete inspection checklist can be found in Appendix B. This wall was rated as the worst of all the walls and warrants a reinspection. In Figure 4-8 of the east side of the wall the coping was moving away from the wall and the panels are misaligned

The condition of the wall was rated as satisfactory but when the risk assessment calculated the wall falls into a fair/poor condition. With these noticeable defects and an adjusted wall rating of 2.39 this wall should be revisited by an engineer and assessed whether repairs are needed.

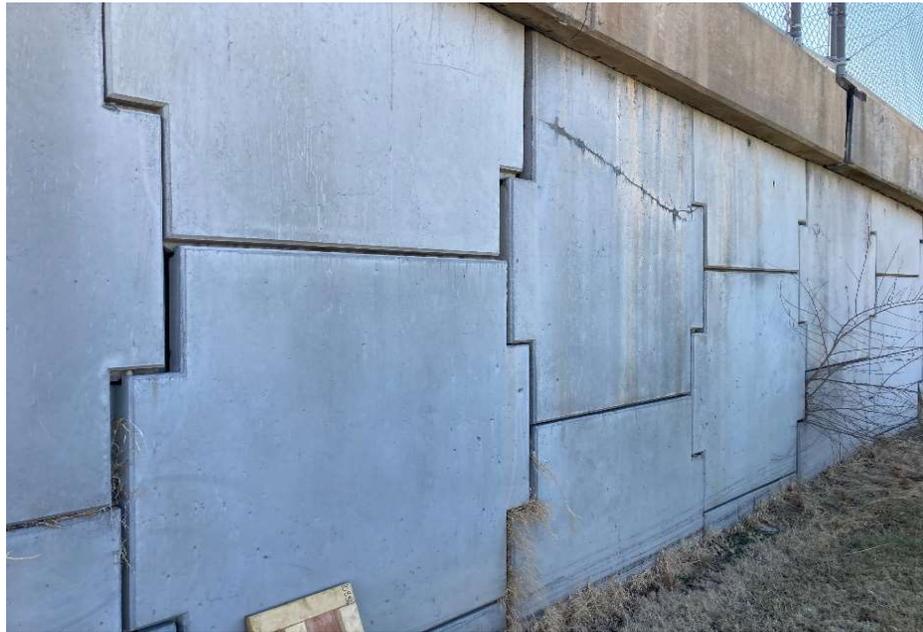
Figure 4-9 West Side US-81 over Railroad

with large gaps between them. The west side of the wall had similar problems with panels moving away from each other and vegetation such as trees growing from them. This is

shown in Figure 4-9. This wall has noticeable panels bulging and misalignment of joints
Figure 4-10.

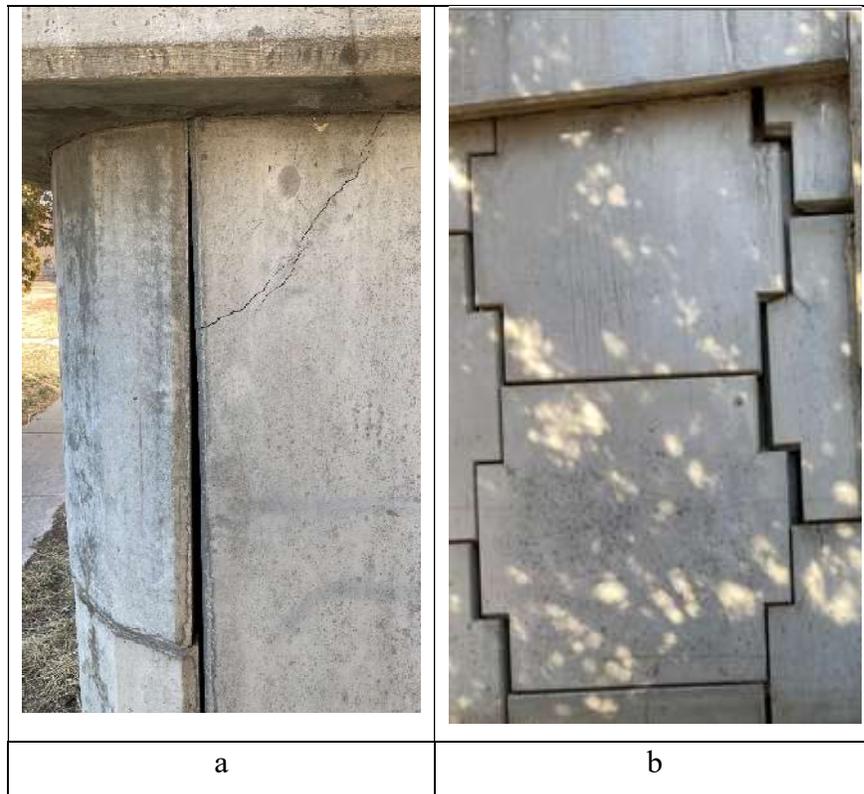
Figure 4-10 Wall issues a) panel bowing, b) misalignment of joints

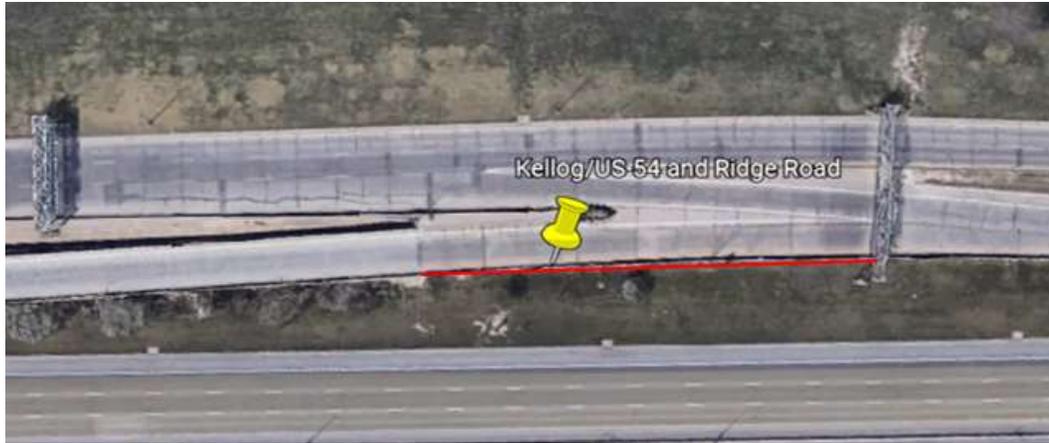
Figure 4-11 US-54 W to S Eisenhower Airport Pkwy

On April 24, 2022, a site visit was conducted on US-54 W to S Eisenhower airport Pkwy Figure 4-11. The retaining wall was rated in satisfactory conditions however the inspector noted some defects. The inspector reported no internal drainage could be found on the bridge and they saw severe staining occurring on the outside of the wall as shown Figure 4-12. The poor internal drainage is thought to be behind the cause of the spalling shown in Figure 4-13. Additionally spalling and cracking to the coping was thought to be from the poor drainage as well. Resistivity tests were conducted on the backfill and they

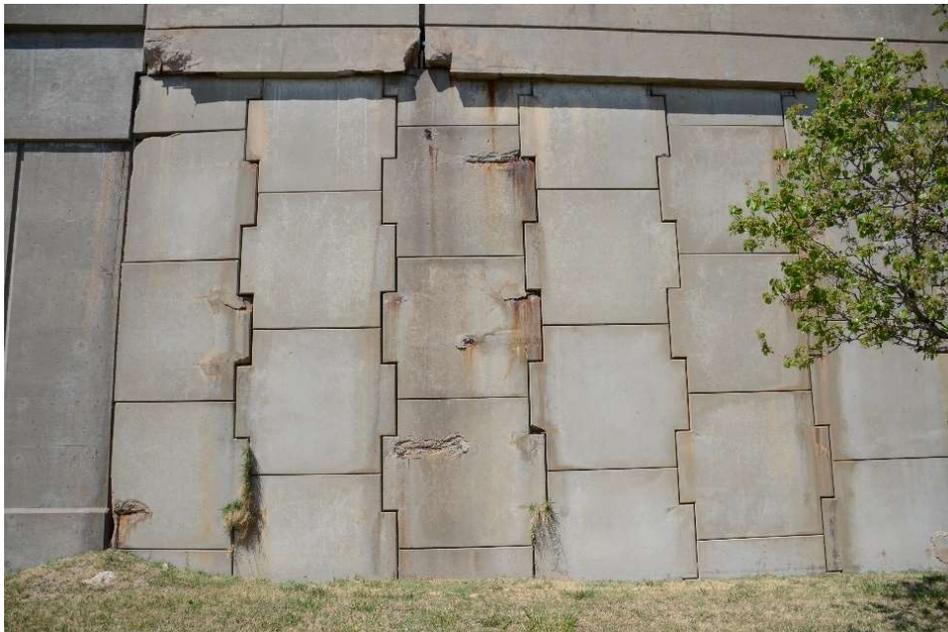
Figure 4-12 US-54 W to S Eisenhower Airport Pkwy Staining

showed very low resistivity measurements. Further testing of the backfill was conducted and iron particles were found. This is thought to be because of the highly corrosive nature of the backfill which is breaking down reinforcement of the wall. The wall had an adjusted rating of 2.91 this wall should be revisited by an engineer and assessed whether repairs are needed.

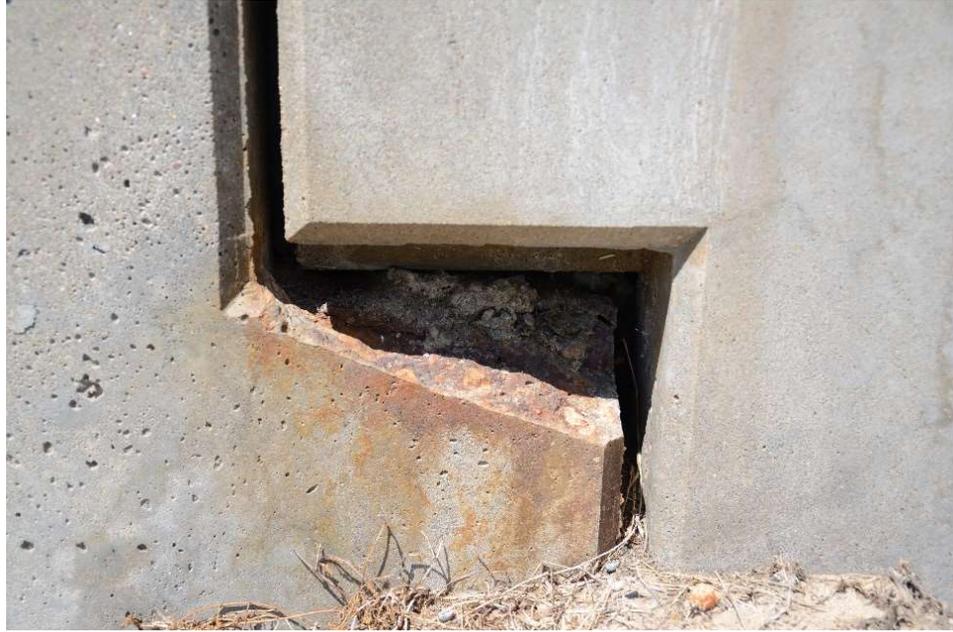
Figure 4-13 US-54 W to S Eisenhower Airport Pkwy Spalling
