EVALUATION OF THE EFFECT OF MICROBIAL ACID ATTACK ON CONCRETE
BRIDGES IN TEXAS

THESIS

by
Luzelva Estrada, B.S. Biology

San Marcos, Texas
December 2011

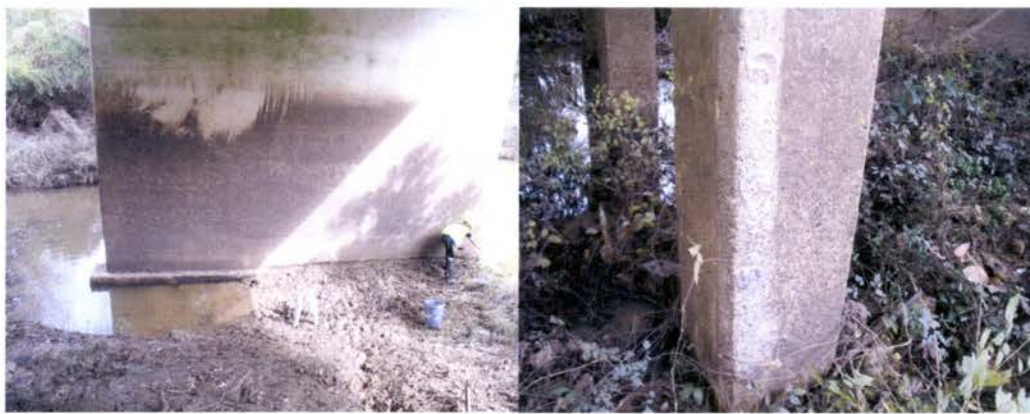
Figure 3: Overview of the level of deterioration at SH 21 at Navasota River (Robertson-Bryan District)

Figure 3, shows the level of deterioration of the second bridge located on SH 21 at the Navasota River (Robertson-Bryan District). A visual inspection of a precast column indicated no apparent deterioration, paste appeared to have decreased, and the bottom of the wall span appeared to have been repaired. Water samples were collected at the north and south end of the bridge. A mud sample was also collected next to the column on the south side of the bridge. Concrete scrapings were taken on the north and south end of the bridge at various elevations. On the first column, scrapings were taken at 36 inches; on the second column, concrete scrapings were taken at 12 inches; for the third column, scrapings were taken at 36 inches; and on the fourth column, concrete scrapings were taken at zero inches. Core samples were extracted from three columns at various

Date of Visit	11/19/2009
General Information	A visual inspection of a precast column indicated no apparent deterioration, paste appeared to have decreased, and the bottom of the wall span appeared to have been repaired.
Visual Inspection	Deterioration level is low
Chemical analysis sampling information	Three water samples were collected, mud sample was collected on the south side of the bridge; concrete scrapings were taken from wall 1 at 6, 18, and 42 inches and column 1 at 6, 18, and 42 inches from the ground
Core sampling information	First set of cores: elevations unknown Second set of cores: 0, 18 and 32 inches from the ground Third set of cores: elevations unknown

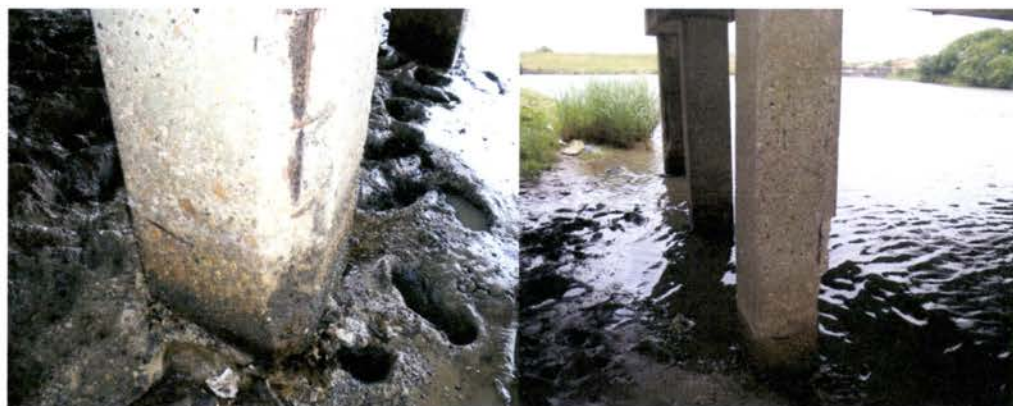
Figure 4: Overview of the level of deterioration at SH 82 at Alligator Bayou (Jefferson County)

Figure 4 shows the level of deterioration of the fourth bridge located on SH 82 at Alligator Bayou (Jefferson County) and built in 1952. Severe deterioration was evident on this bridge as the main reinforcement was exposed. There was surface deterioration and rebar corrosion; however, the concrete cores samples that were extracted appeared to be in good condition. Two water samples and two mud samples were obtained at this site. The first mud sample was obtained from underwater underneath span 1, and the second mud sample was obtained from the bank. Four concrete scraping samples were also obtained. The first sample was from span 0, 34 inches above the ground on column 5. This was a non corroded concrete sample. The second sample was a surface organic sample and was obtained from span 1, column 3 at 6 inches below the water level. The third sample was a corroded concrete sample obtained from span 1, column 6 at 6 inches above the water level. The last sample was a corroded concrete sample obtained from span 1, column 5 at 3 inches above the water line.

Date of Visit	4/30/2010
General Information	Built in 1952
Visual Inspection	Bridge site showed severe deterioration with surface deterioration, exposed main reinforcement, and rebar corrosion.
Chemical analysis sampling information	Two sets of water and mud samples were collected Concrete scrapings were taken column 3 6 inches below the water level, column 5 3 and 34 inches above, and column 6 at 6 inches above
Core sampling information	First set of cores: column 6 span 1 at 34, 45, and 85 inches from the ground The second set of cores: column 3 span 1 at 4, 8, and 28 inches from the ground Third set of cores: column 3 span 1 at 16 and 40 inches from the ground.

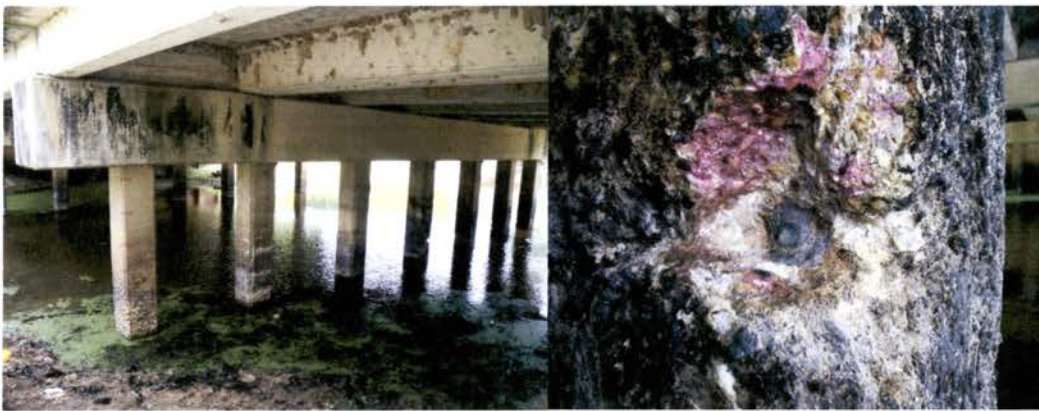
Figure 5: Overview of the level of deterioration of SH 31 West Bound at Kickapoo Creek (Henderson County)

Figure 5 shows the level of deterioration of the eighth bridge located at SH 31 West Bound at Kickapoo Creek (Henderson County); 3.2 miles west of the Smith County line near Chandler, Texas. The bridge was built in 1930 and has 2 spans. A visual inspection of the bridge indicated that the bridge appears to have moderate scaling with approximately $\frac{1}{4}$ - $\frac{1}{2}$ inches of penetration along the waterline of the concrete pillars. There is severe scaling of column 4 and column 5 at the water line with a penetration of approximately 3 inches. The columns, from 0 to 30 inches above the water line, show scaling of the surface cement paste and exposure of coarse aggregate. At 30-42 inches

above the waterline, the cement paste has mild scaling and column 4 has rebar corrosion. The following columns were tested for span 1 from the west side (the water level was 3 feet deep): column 2 from the north side, and column 4 from the south. Two water samples and two mud samples were taken at the north and south end of the bridge. Eight concrete scraping samples were taken from two columns at various elevations from the ground. The first set of concrete scrapings was taken from span 1 column 2, at 6, 18, 30, and 54 inches from the ground. The second set of concrete scrapings was taken from span 1 column 4 at 6, 18, 30, and 54 inches from the ground. Table 8 presents a summary for samples collected at SH 31 West Bound at Kickapoo Creek (Henderson County).

Date of Visit	4/14/2011
General Information	Built approximately 1930; west bound bridge site consisting of 2 spans
Visual Inspection	Moderate to severe deterioration.
Sampling information	Two sets of water and mud samples were collected on the north and south end of the bridge Concrete scrapings were taken from two columns from span 1; Column 2 span 1 taken at 6, 18, 30, and 54 inches from the ground; Column 4 span 1 taken at 6, 18, 30, and 54 inches from the ground

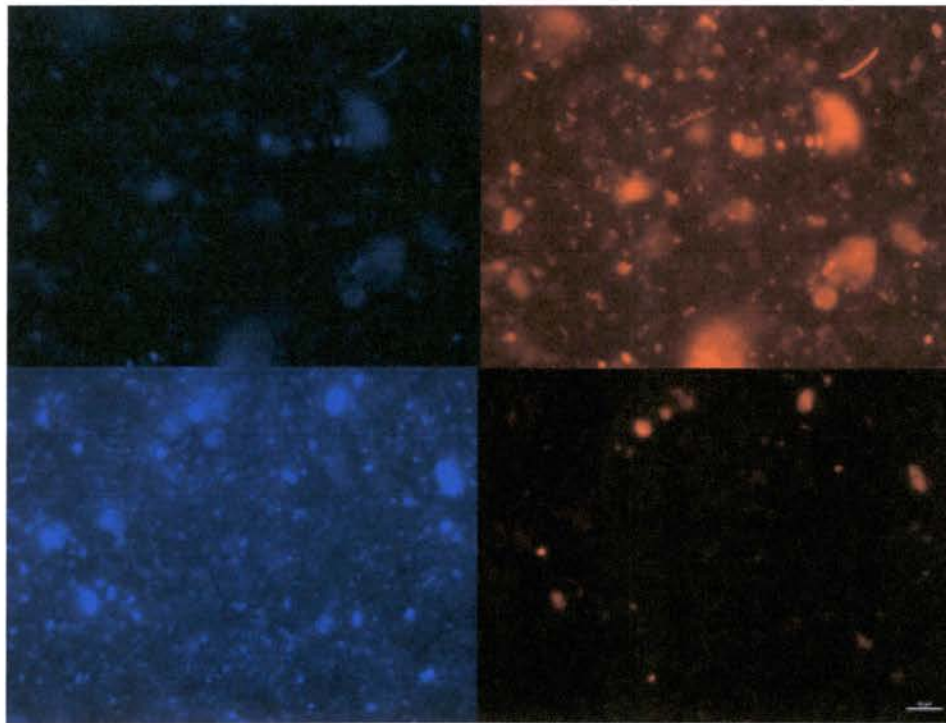
Figure 6: Dapi: Cy3 microbial populations of FM 276 at Patroon Bayou (Sabine County, top 5-C-1-12 and bottom 5-C-2-10)

Table 32, shows the percent average Cy3-EUB338/DAPI of organisms as well as the absolute numbers of organisms found using the Cy-3EUB338 probe and DAPI stain.FM 276 at Patroon Bayou (Sabine County). For the biological samples taken on column 1, the percent average of Cy3-EUB338/DAPI ratio was higher at elevations closest to the ground. Higher numbers were also observed at elevations closest to the ground with absolute counts done with the Cy3- EUB338 probe and DAPI-stain decreased at higher elevations. For biological samples taken on column 2, the average

ratio percent of EUB338/DAPI was moderate. Absolute individual counts for Cy3-EUB338 and DAPI-stain were high at lower elevations and decreased with increased elevation.

Figure 6 shows the microbial populations taken from sample 5-C-1-12; DAPI (top left-blue picture) shows all organisms found, and the Cy3 (top right-red picture) shows specific for the Domain Bacteria found with the EUB 338 probe.
