# MECHANISMS OF PROCESSING-RELATED DEFECTS IN PMR-15/CARBON COMPOSITE MATERIAL LAMINATES

## THESIS

James E. McBride

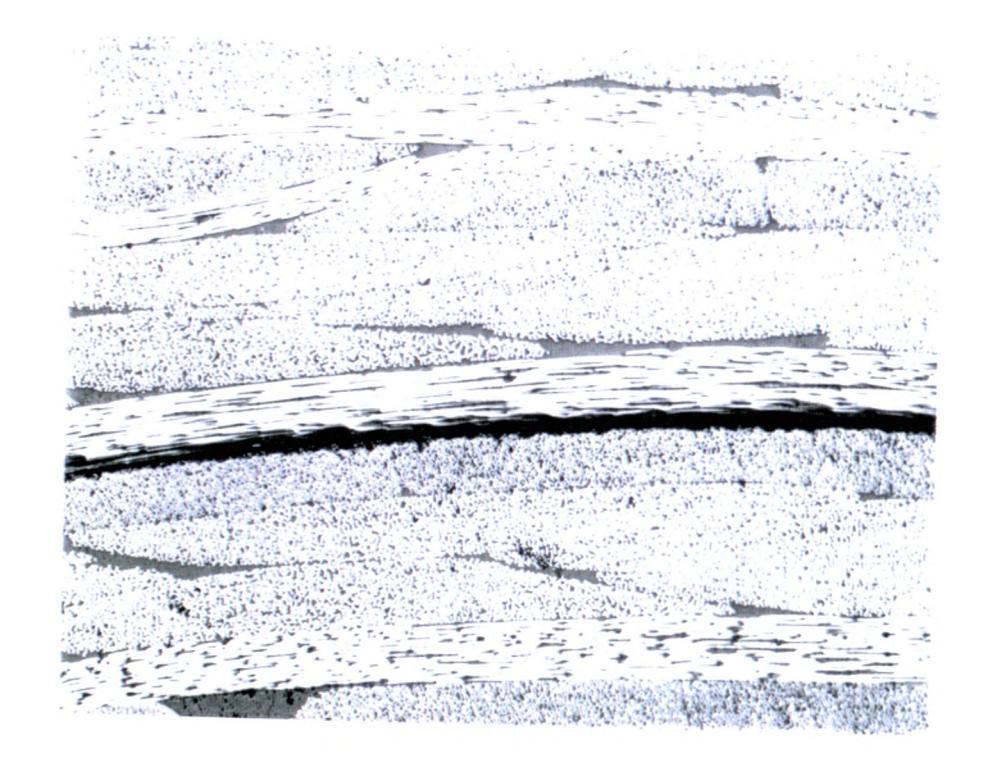
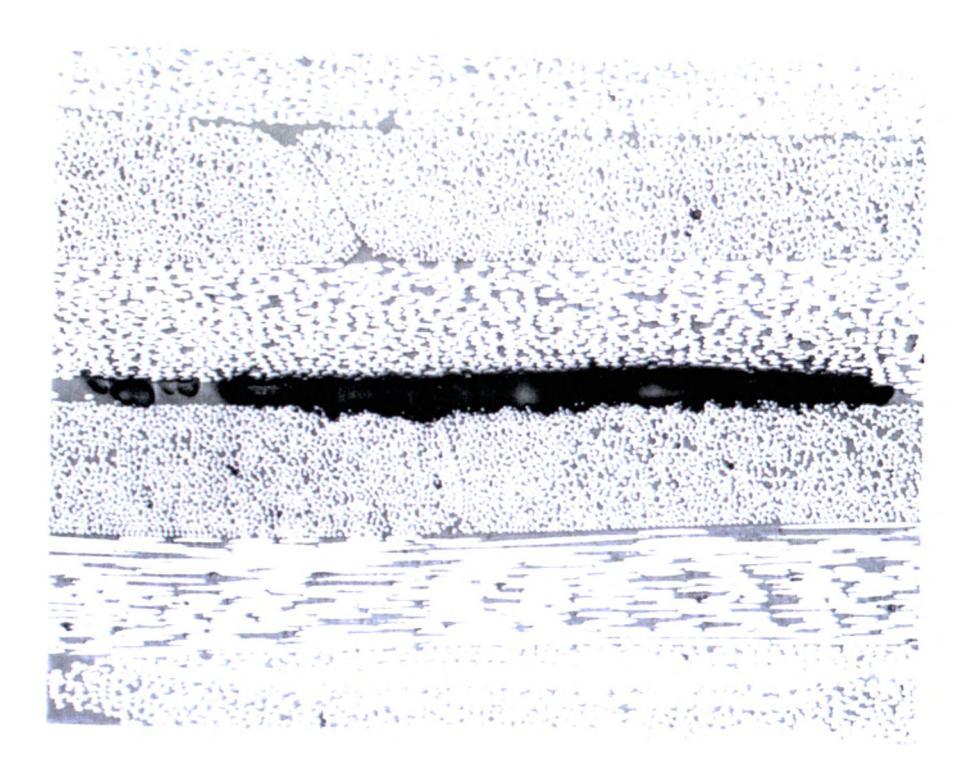
# DUCT A FIGURE 2.1C

Duct A is a classic example of both types of failures discussed above. It was noted after cross sectioning the duct that a large delamination was present along one of the axial flanges of the duct and gross voids were present around some of the boss plies. The duct originally failed its C-Scan inspection stage of processing. The C-Scan (Fig. 2.1b) clearly shows that duct A exhibits many discontinuities around the middle boss plies. These discontinuities are characterized by the green color near the boss ply areas on the C-Scan. The cross sections were also further analyzed by cutting the sections into small pieces. The pieces were mounted in Lucite disks and the surfaces were polished using a Leco metallographic polishing instrument. The polished

# Fig. 2.1c(i) 50X

Fig. 2.1c(ii) 100X

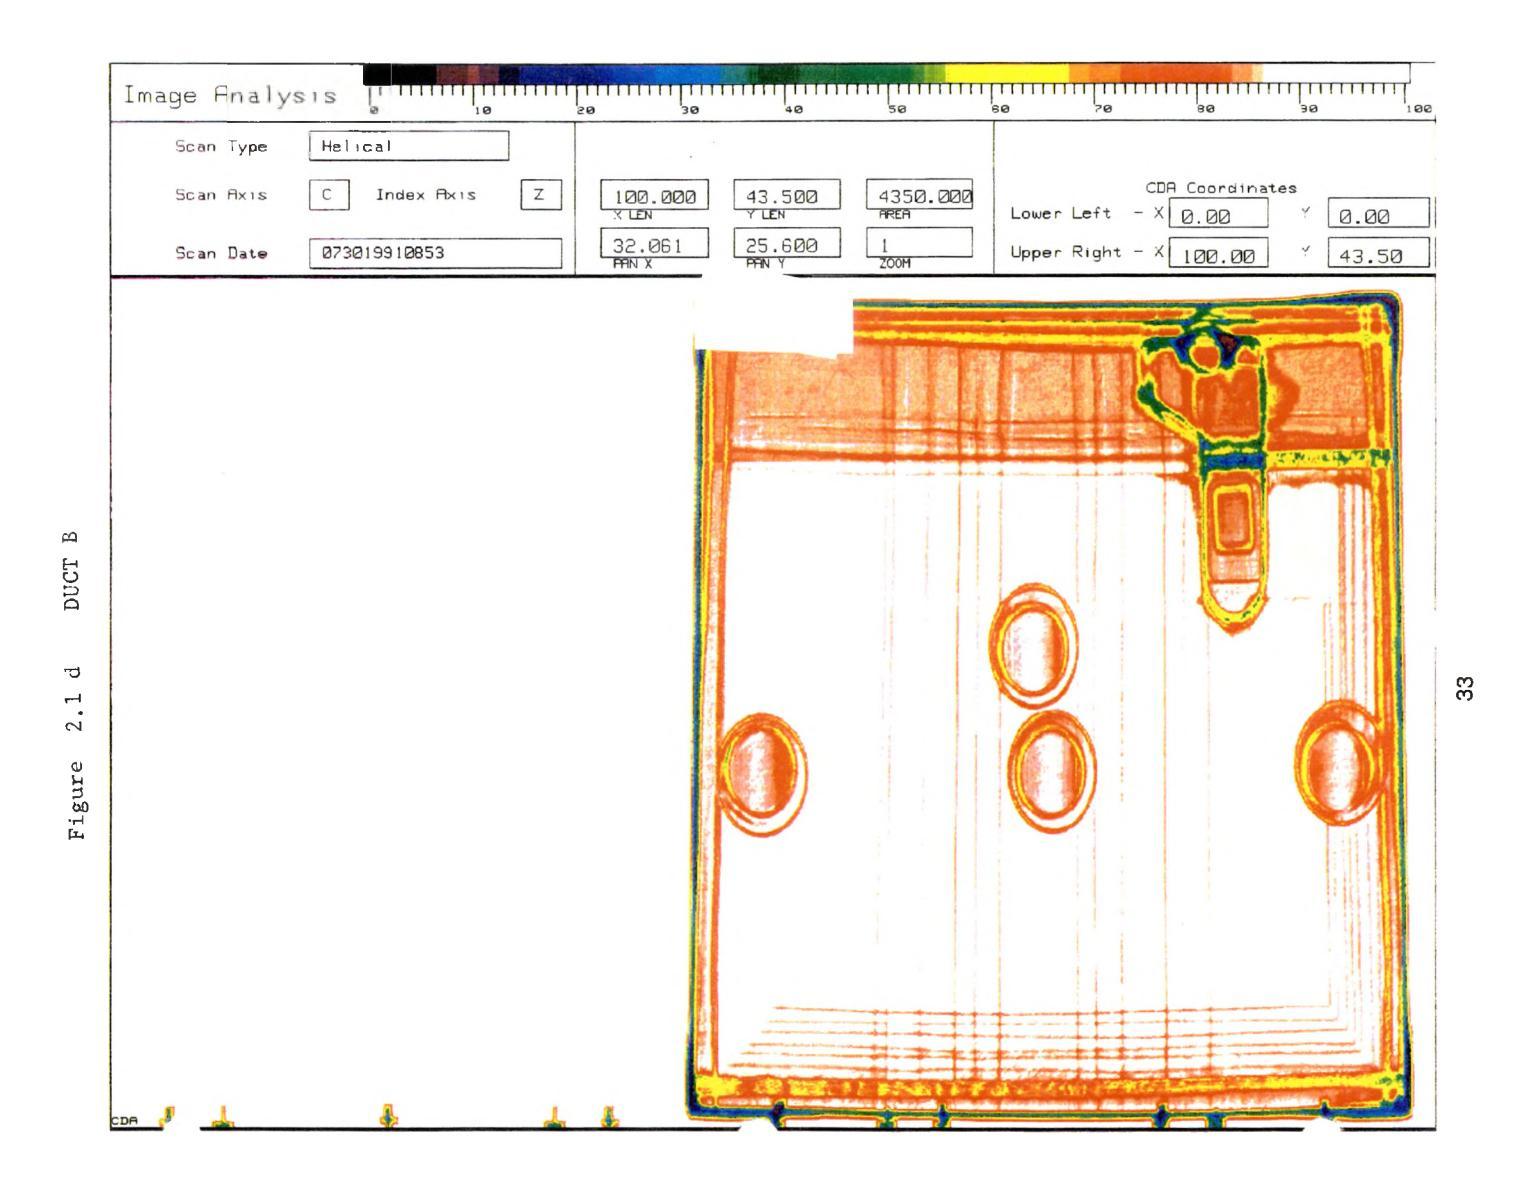
Duct B greatly exemplifies the case of mass void growth around the boss areas of the duct component structure. The upper right corner of the C-Scan in fig. 2.1d indicates severe discontinuities at the edges of the hatchet pad. The severity of the discontinuities is clearly marked by the violet color in

the defect region of fig. 2.1d.

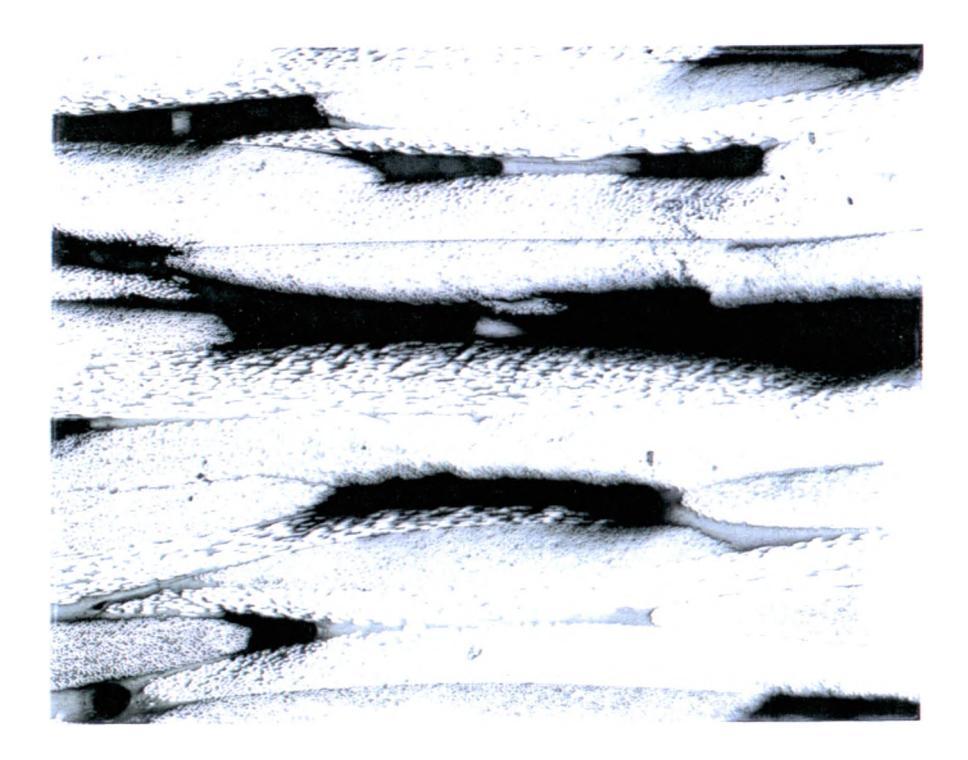
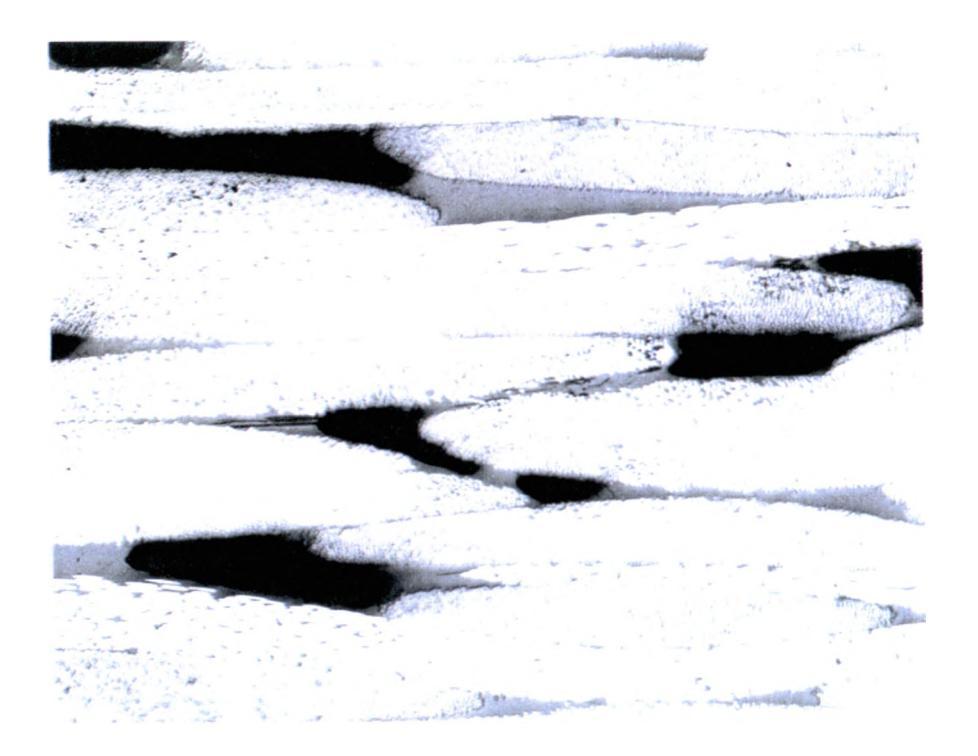
# DUCT B FIGURE 2.1 E

The same microscopic analysis was performed on duct B as that on duct A. Samples for the microscopic study were taken from cross sections in the hatchet pad region of duct B. The samples were prepared in a similar manner to those in the microscopic study of duct A. Results from this analysis are displayed in fig. 2.1e and differ somewhat from those in the same analysis of duct A. Figure 2.1e(i) is a micrograph of a sample cut along the axial direction of the hatchet pad. This micrograph was taken at 50X magnification and reveals many voids in the specimen. Note that a large number of voids cover this micrograph and the sizes of these voids are large in comparison to the void region of fig. 2.1c(ii). These observations tend to support that the prepreg laminate in this region of the mold may not have been completely purged of trapped air or volatile contents. The sample for figure 2.1e(ii) was cut perpendicular to the axial direction of the hatchet pad. This micrograph was taken at a magnification of 50X and shows a similar picture to that of fig. 2.1e(i). However, the voids in this micrograph are not as wide as those in fig. 2.1e(i) because of the direction from which the view was taken.

Fig. 2.1e(i) 50X

Fig. 2.1e(ii) 50X

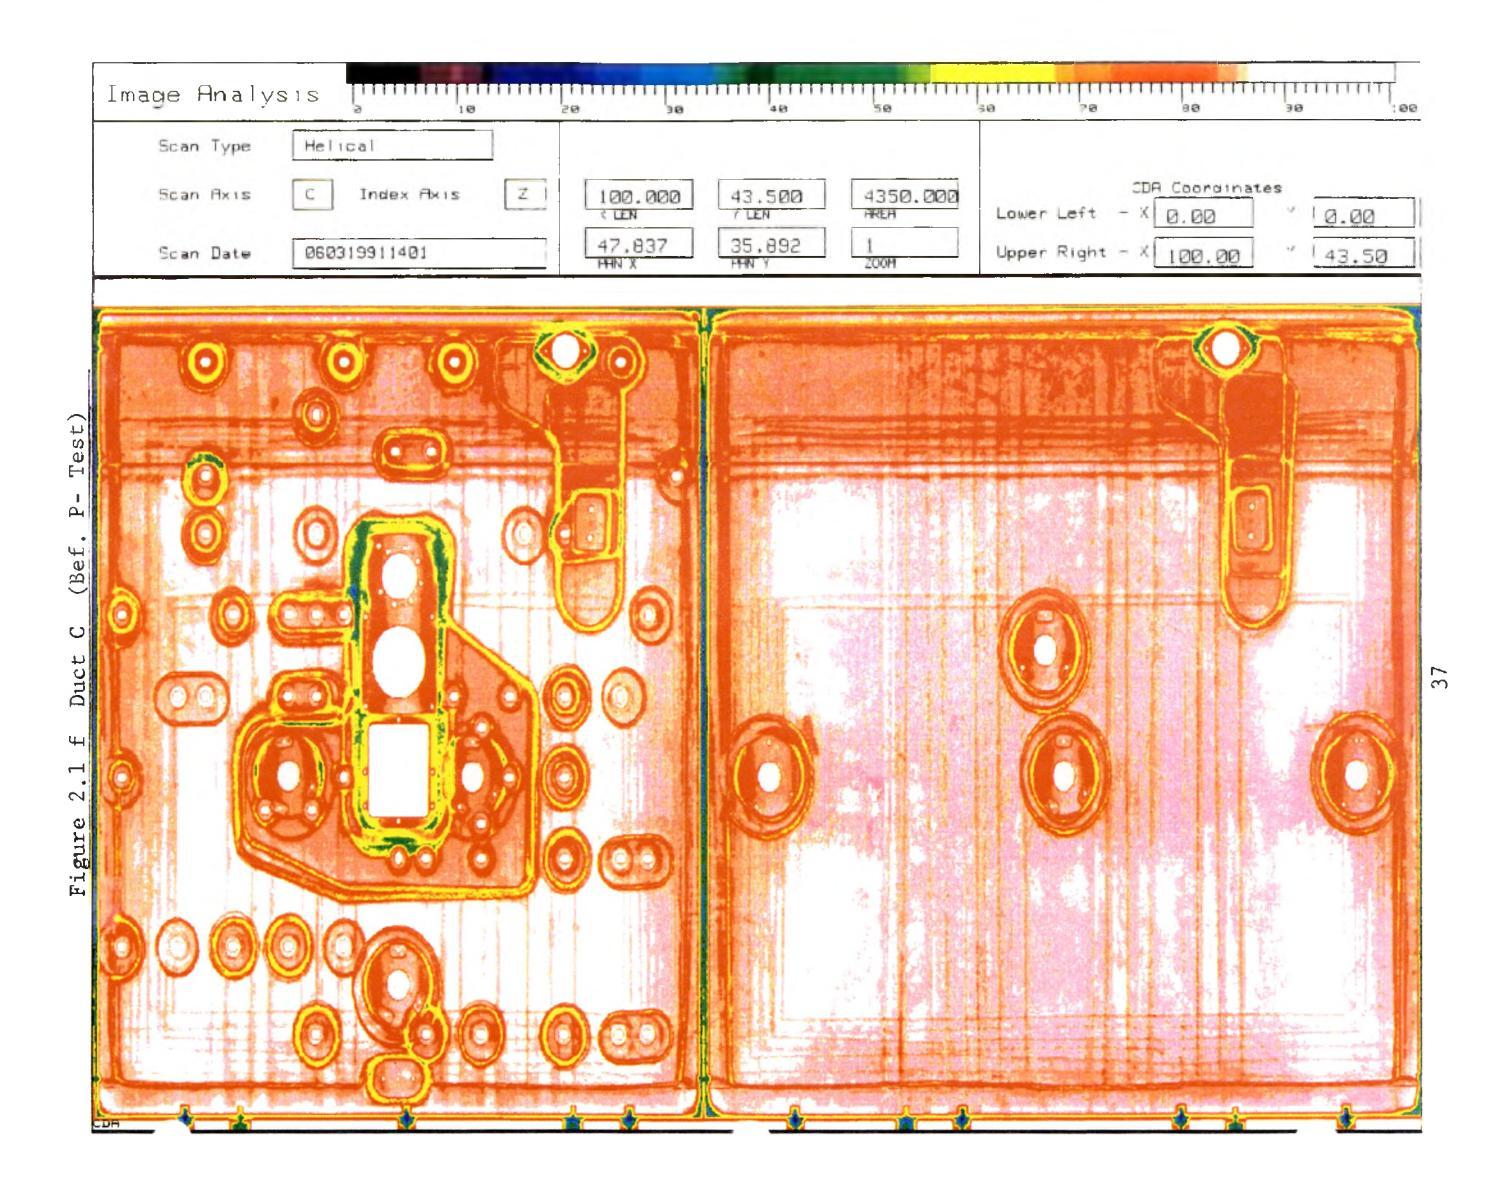
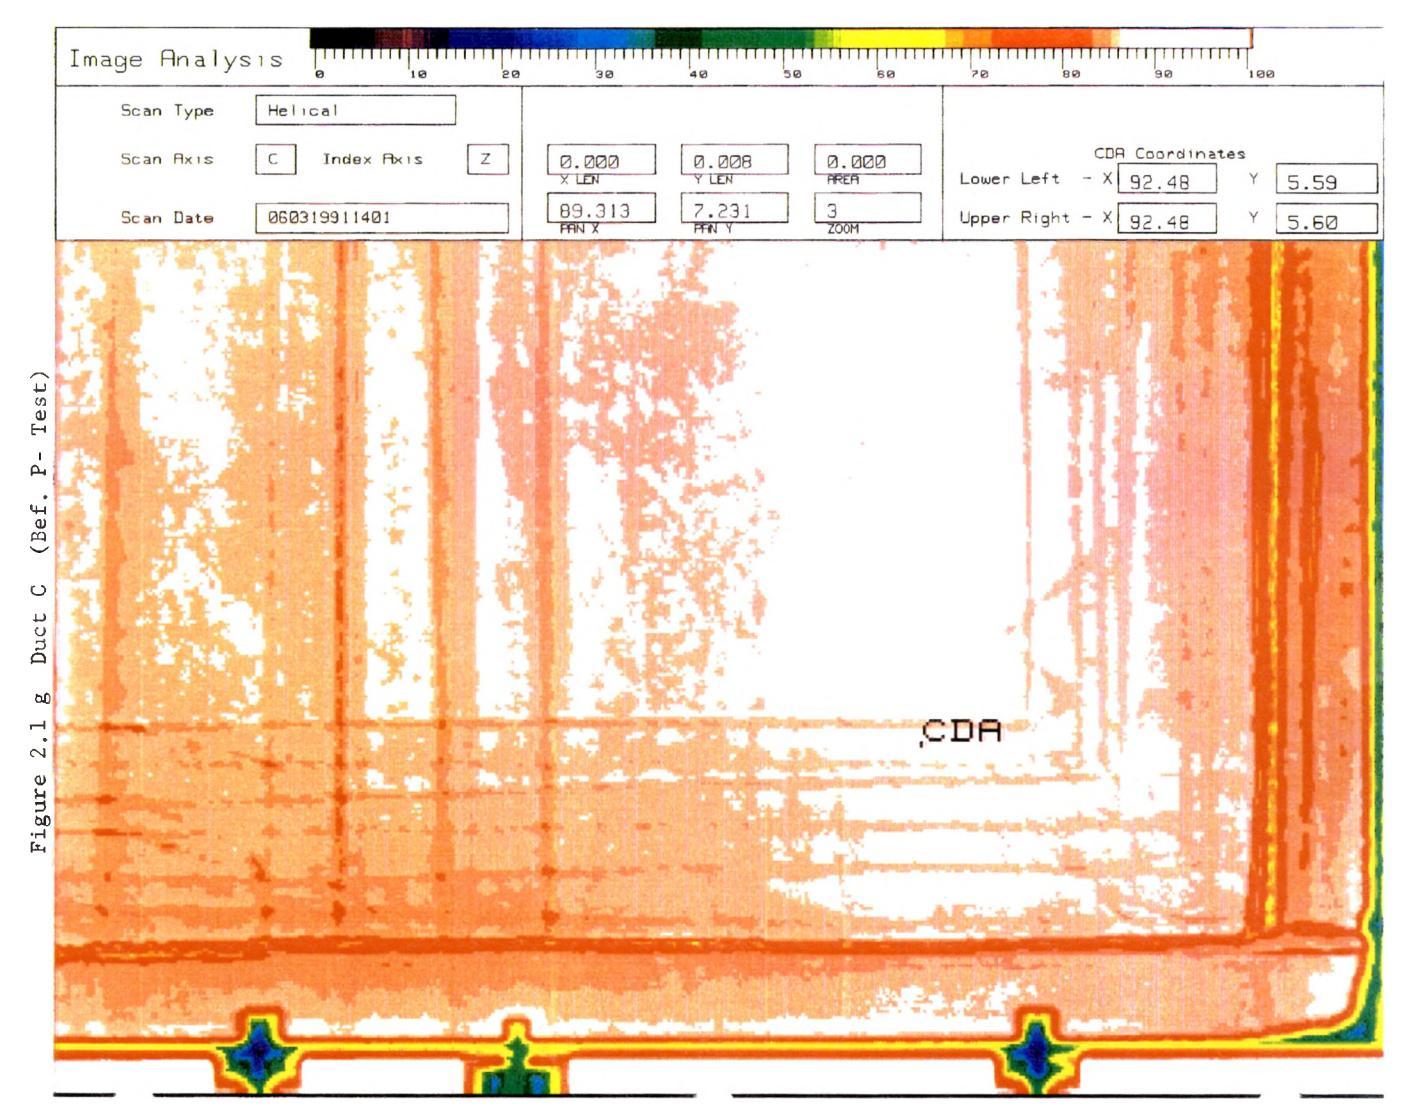
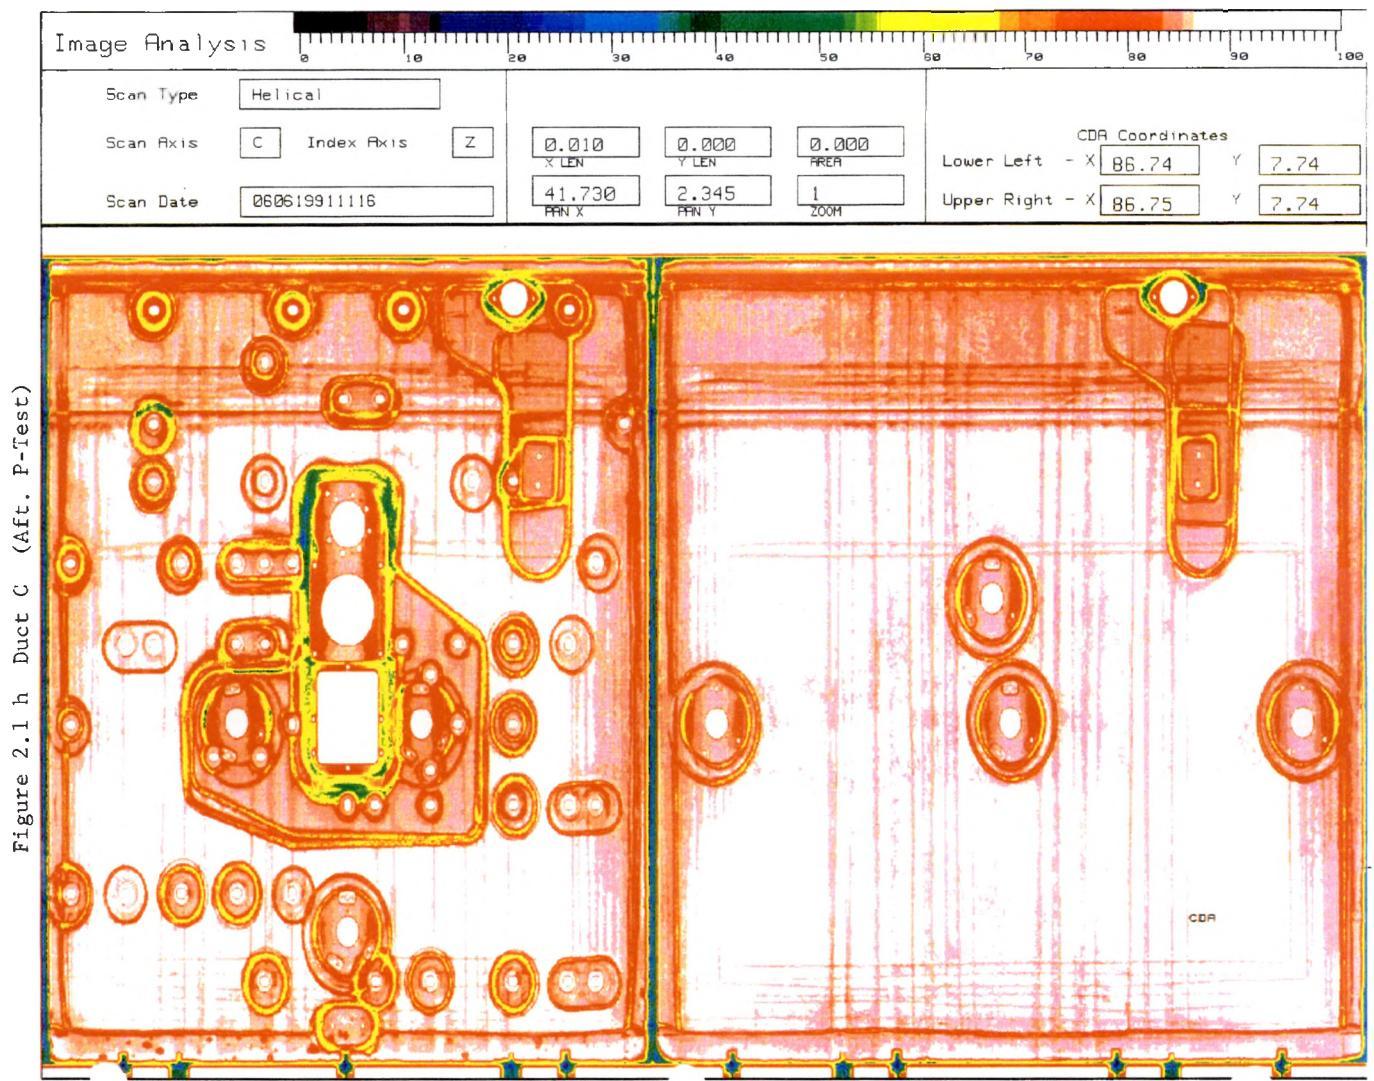
Scan Type	C Index P	as Z	Ø.010 × LEN	0.000 Y LEN	Ø. ØØØ AREA	Lower Left	CDA Coordinate	эs Ү [
C (Aft. P-Test)	Scan Date	Ø60619911116		89.313 HN X	7.231 PPN Y	3 200M	Upper Right	- X <u>86.75</u>	
e 2.1 i Duct					1997 - Santa S				
Figur		县

The final duct analyzed (Duct C) did not fail inspection immediately following the curing process. The failure occurred during a pressure test stage of the component processing scheme. This test was implemented to ensure that service pressure exerted on the interior walls of the engine duct would not exceed specified limits.

The C-Scan prior to the pressure test is pictured in fig. 2.1f. It differs from the C-Scans of fig. 2.1b and fig. 2.1d in that both halves of the duct are displayed. Note the green line that runs along the far right side of fig. 2.1f. These lines are present around the edges of all three duct C-Scans because of how the sound beam is reflected and refracted along these edges. The line in question runs along the axial length of the duct half, and is fairly uniform until it reaches the top and bottom corners. Figure 2.1g displays a magnified image of fig. 2.1f in the lower right hand corner of the right half. Note once again the fair uniformity of the green line until it reaches the bottom corner.

Figure 2.1h is a C-Scan of the duct halves following the pressure test. The Scan appears virtually identical unless it is closely inspected. At the bottom right corner, the uniformity of the green line changes and therefore implies a defect in the component. A magnified image of this area in fig. 2.1h is shown in fig. 2.1i on the following page. Comparing the specified lines of figures 2.1f and 2.1h, one can observe a highly notable difference. The blue color of the line in fig. 2.1h implies a larger degree of attenuation of the ultrasonic signal. The increased signal loss indicated that a delamination was created during the pressure test.

The development of the above mentioned defect in duct C may have occurred as a result of a foreign substance introduced into the laminate. This could have resulted by virtue of not removing all of the polyethylene backing film on a PMR-15 prepreg sheet while the duct was being molded. If this were

the case, it would answer two pertinent questions. The first question is why did the C-Scan before the pressure test not indicate the presence of the foreign material? This is easily explained since the melting point of polyethylene is between 230 - 270 °F.[6] If the polyethylene was baked into the duct, the maximum temperature of the cure would be more than sufficient to completely melt the piece of polyethylene film. Upon melting, the film would diffuse into the laminate and chemically combine with the PMR-15 resin at this point. When the duct was C-Scan inspected, the foreign material would not have been detectable because of its mixture into the PMR-15 resin. This is conceivable by virtue of the fact that the C-Scan signal is attenuated by a material boundaries of differing density. The melted polyethylene and PMR-15 would become a material of uniform density. This would render the C-Scan inspection unable to detect the presence of the foreign material.

The second question is why did the duct fracture during the pressure test? Since the polyethylene is a foreign material to the PMR-15 matrix, it caused poor covalent bonding to be achieved between the interlaminar interfaces. As a result of this, the fracture was created by the force imposed during the pressure test on the interior walls of the duct.

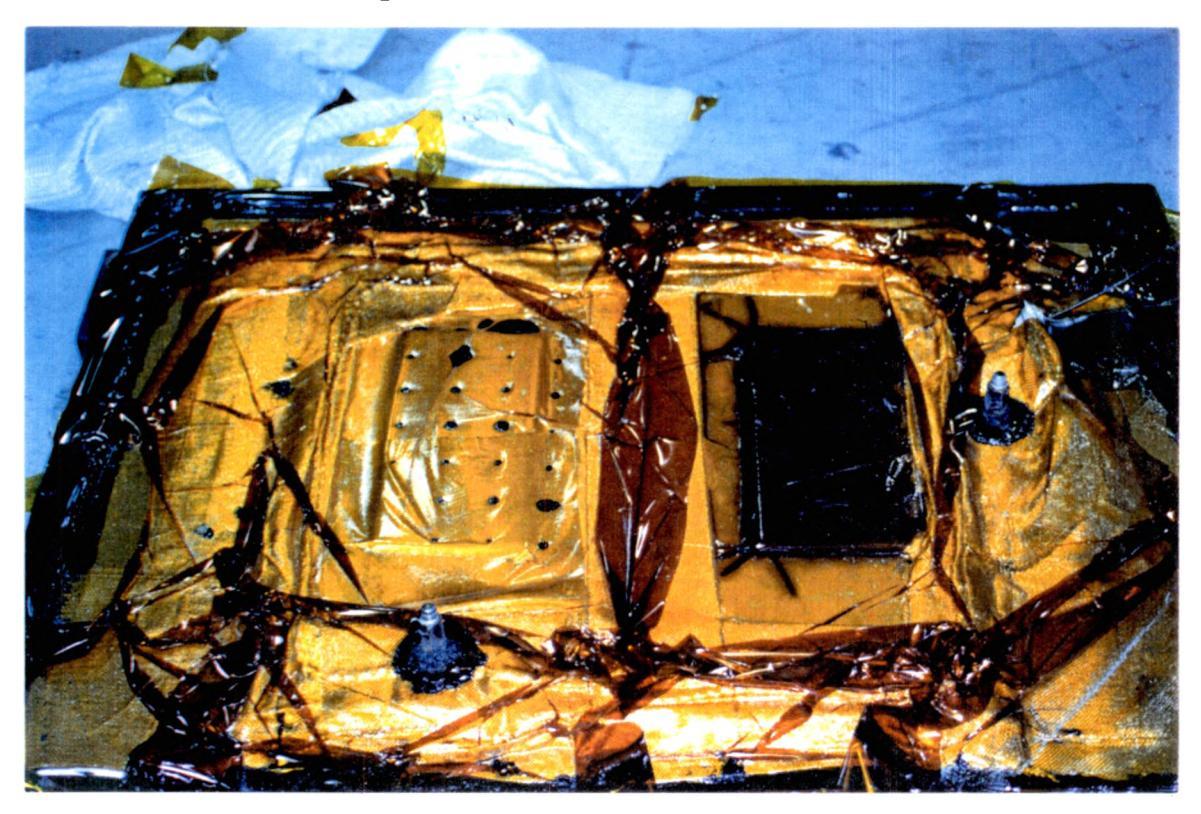
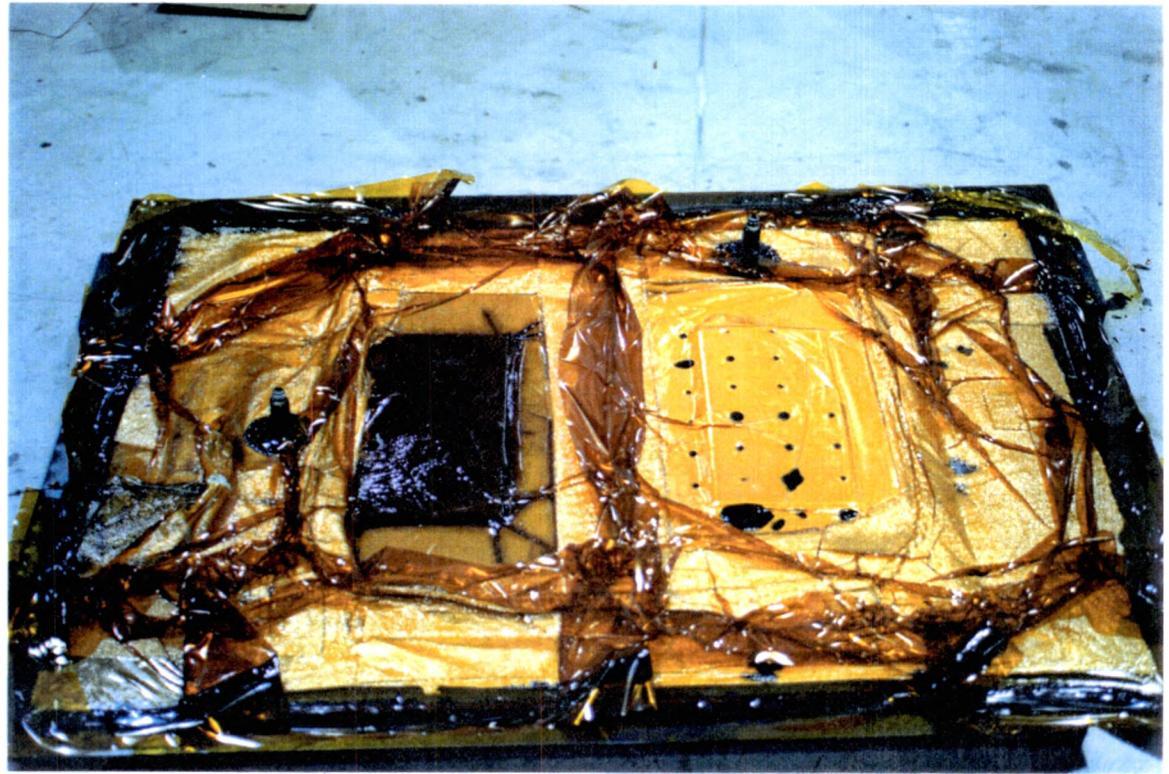
Figure 2.2 a

- (B.) 1.) Smooth surface, with wrinkles running across panel surface.
  - 2.) Much resin bleeding around edges of panel (Bag).
  - 3.) Lost 17.9% of weight due to expelled volatile contents.
- Condition of mold and bag -

Bleeding apparent around edges of breather cloth and bag.

Panel B (Right side of fig. 2.2a(i)/Left side of fig. 2.2a(ii)) however, which was not properly ventilated, revealed that the resin sought to escape from under the non-perforated resin barrier. This is illustrated by the presence of the black edges of panel B and the "Crow feet" lines at the corners in fig. 2.2a. Panel B also retained 2.3% more of its original prepreg weight because of poor exhaustion of its volatile contents and the inability of the resin to escape through the breather cloth. Upon visual inspection of the panel surfaces outside of the bag, it was noted that panel A (Figure 2.2a(i)) had a rough surface contour and panel B (Figure 2.2(ii)) had a smoother surface. Each panel had notable creases across their width. The creases could have been caused by virtue of the fact that panel A was under a compaction force of over 15,000 lbs. and panel B, a force of over 15,000 lbs. during a pressure application in the autoclave.

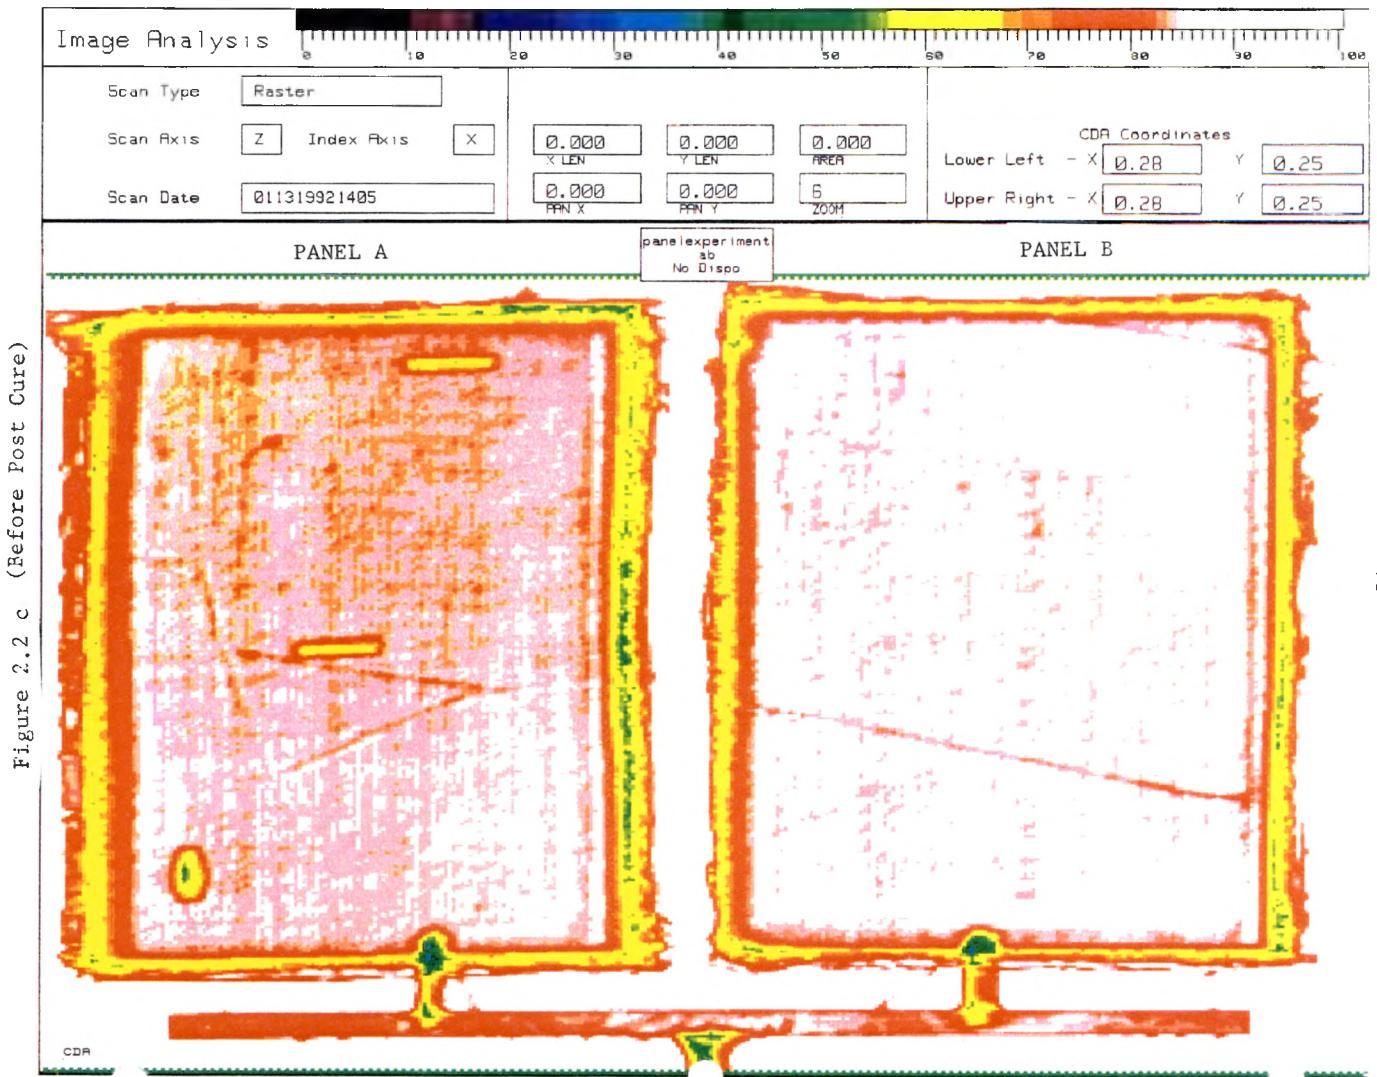
(Before Post Cure) 2.2

The C - Scan image in fig. 2.2c shows the panels following the autoclave cure, prior to the post cure. This figure indicates that laminate A was fully consolidated except for the areas in which the material inserts were placed. The brass insert is at the top right of the C-Scan, the graphite insert is in the middle and the teflon insert is at the bottom left of fig. 2.2c. From fig. 2.2c, it can also be noted that the teflon insert appeared to have expanded during the autoclave cure which can be accounted for by the fact that teflon will cold flow under pressure. A closeup C-Scan of the teflon insert is pictured in fig. 2.2d from which it appears that the center of the insert is more dense as a result of the green color. The center of the insert could have become more dense as

a result of the compression forces generated within the laminate. The compression forces acting on the sides of the insert could have caused the center of the teflon insert to become more dense. This is conceivable by virtue that teflon is a thermoplastic polymer and its molecular structure can be easily reoriented.

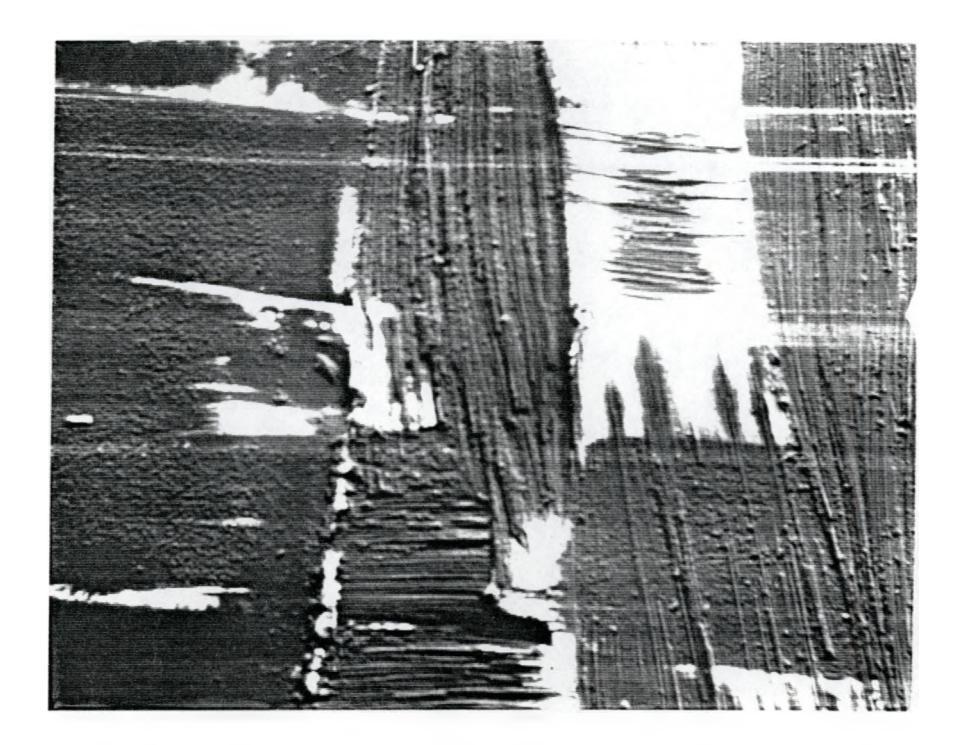
Teflon Insert/Panel A 2.3a(i)

If the fracture surfaces of specimen one, two and three are examined closely in figures 2.3a and 2.3b(i), a line down the middle of each can be noted. This line represents a division between the surface of one of the inserted materials in test panel A and the surface of an interlaminar region next to the defect. The surface of fig. 2.3a(i) reveals a rough surface contour over the area where the teflon insert was positioned and to the right of that is the interlaminar region where it appears that the resin and fibers both contributed to the failure of the laminate. The brass insert surface in fig. 2.3a(ii) does not resemble the teflon insert surface, it appears that this surface is smoother. A reason for this difference could be attributed to the cold flow properties of the teflon insert under the extreme compaction force within the autoclave during

the application of maximum pressure. To the right of the insert surface the interlaminar region appears to have fractured in a similar manner to that of fig. 2.3a(i).

In conclusion, PMR-15/Carbon composite material laminates can be subject to at least two modes of failure. If the resin component of the material is uncontaminated, then the material will fail by means of both the fibers and the resin. This is explained by an equal loading of the matrix and the fibers when the laminate is under a sufficient stress to break the interfacial bond between plies (Figures 2.3a and 2.3b).

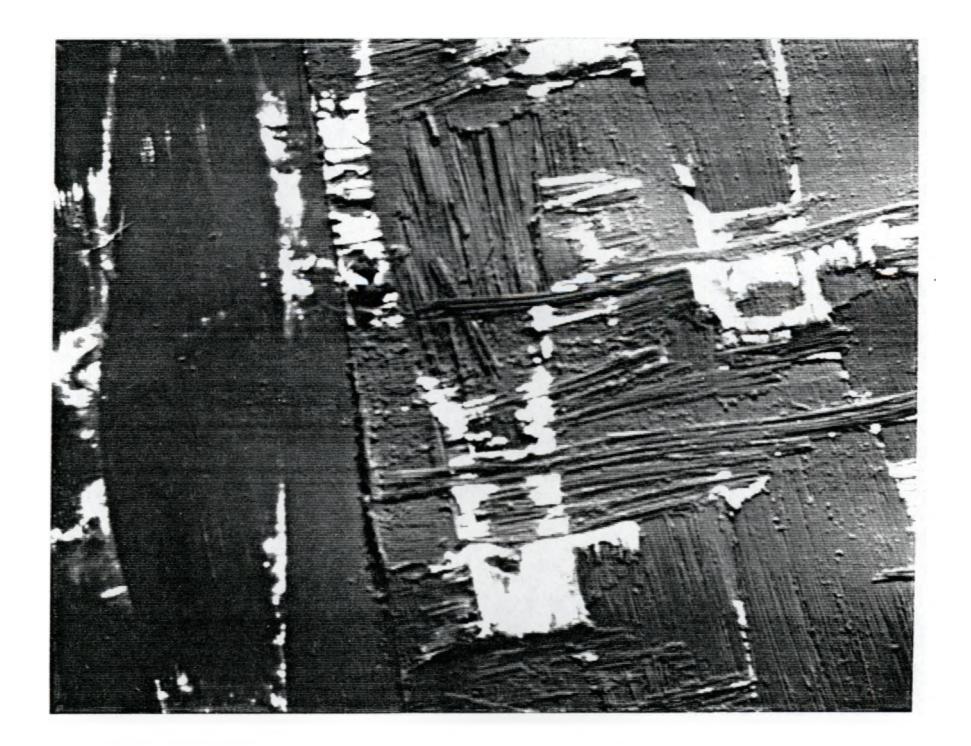
Brass Insert/Panel A 2.3a(ii)

The section containing the brass insert, was cracked by application of a shear stress along the section. After cracking the section, the laminate was peeled apart and the surfaces exposed an unchanged brass insert which was easily removed.

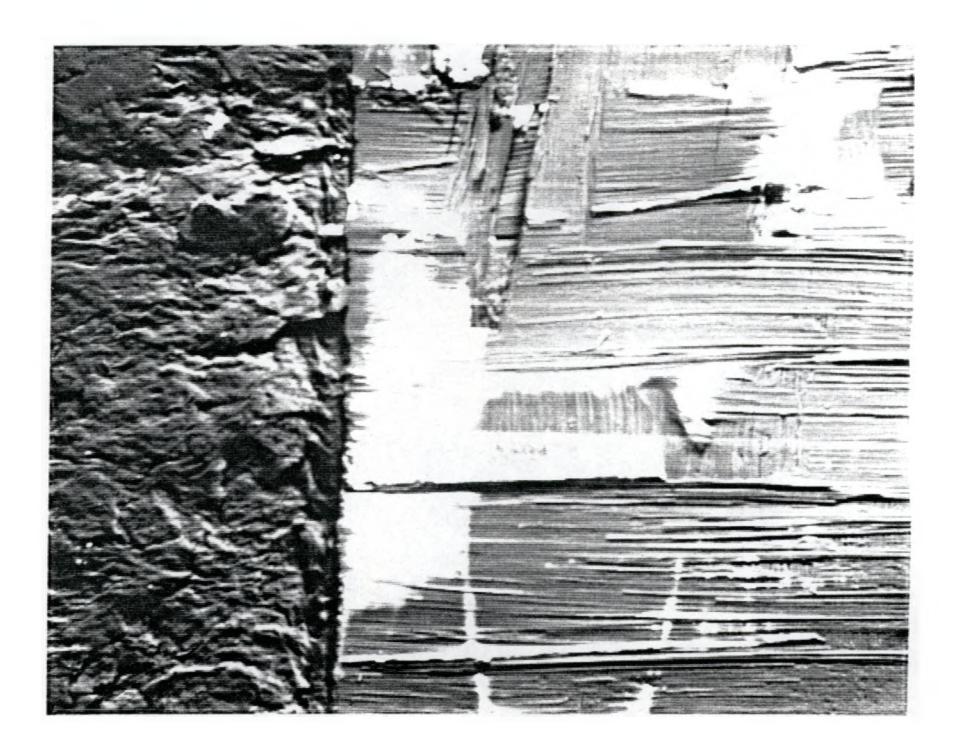
Graphite Insert/Panel A 2.3b(i)

In fig. 2.3b(i) the graphite insert surface shows a well defined three dimensional image which may be a result of the graphite's conductive properties. The division line between the insert surface and the interlaminar surface is clearly defined in this micrograph. The interlaminar surface greatly resembles the interlaminar surfaces picture in fig. 2.3a implying a similar mode of failure. The interlaminar surfaces of figures 2.3a and 2.3b(i) show a strong correlation to a fracture surface obtained in a similar study by Kwarteng, Dumbleton, and Stark (Reference 8). This study maintains that the fracture surface resembling that of the above mentioned figures was created by a combination failure of the resin and the fibers in a fiber reinforced composite material.

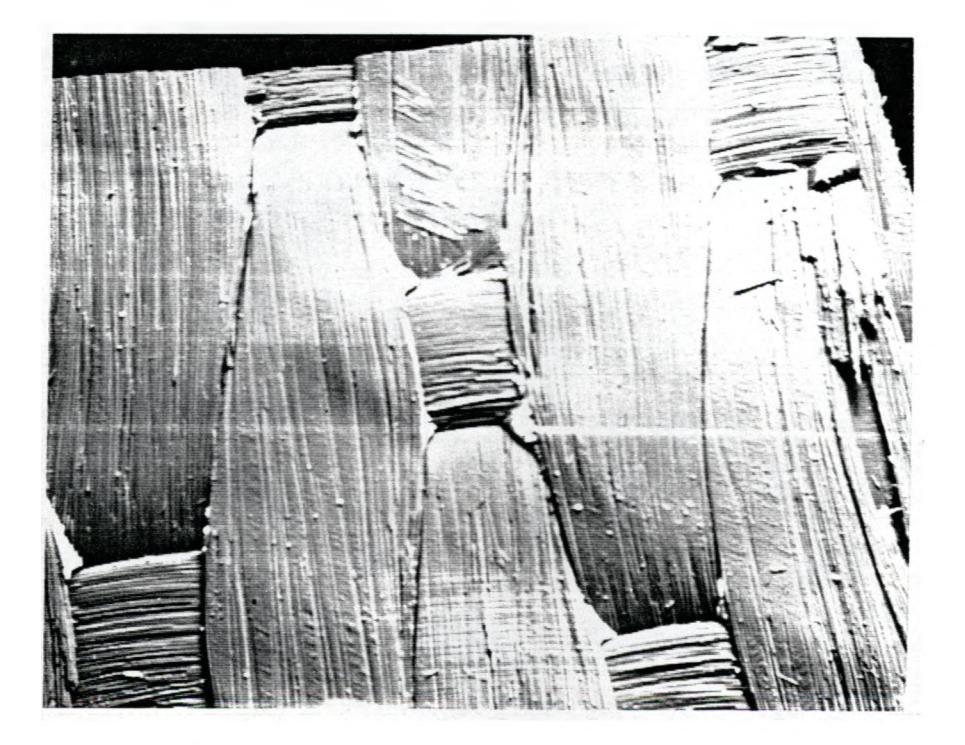
Delamination Duct-C 2.3b(ii)

1.) Fracture Mechanism: Failure by resin alone
Figure 2.3 a

Figure 2.1d is an electron micrograph of the fracture surface of a delaminated region from the above mentioned engine duct. The majority of the fracture surface appears to be well ordered, implying that the mode of failure is not a combined failure of both the fibers and the resin. A majority of the fibers are not distorted which suggests that the failure mode was attributed to the resin alone. In consideration of the above deductions, one can assume that poor interfacial bonding was achieved between the plies of the laminate because of the contaminated resin in the area of the delamination.

The second mode of failure can be attributed to an inconsistency in the chemical make up of the resin which prevents a high number of covalent bonds to form between the ply interfaces (Figure 2.3b(ii)).
