RIPARIAN RESTORATION: AN OPTION FOR VOLUNTARY BUYOUT
LANDS IN NEW BRAUNFELS, TX

THESIS

Master of APPLIED GEOGRAPHY

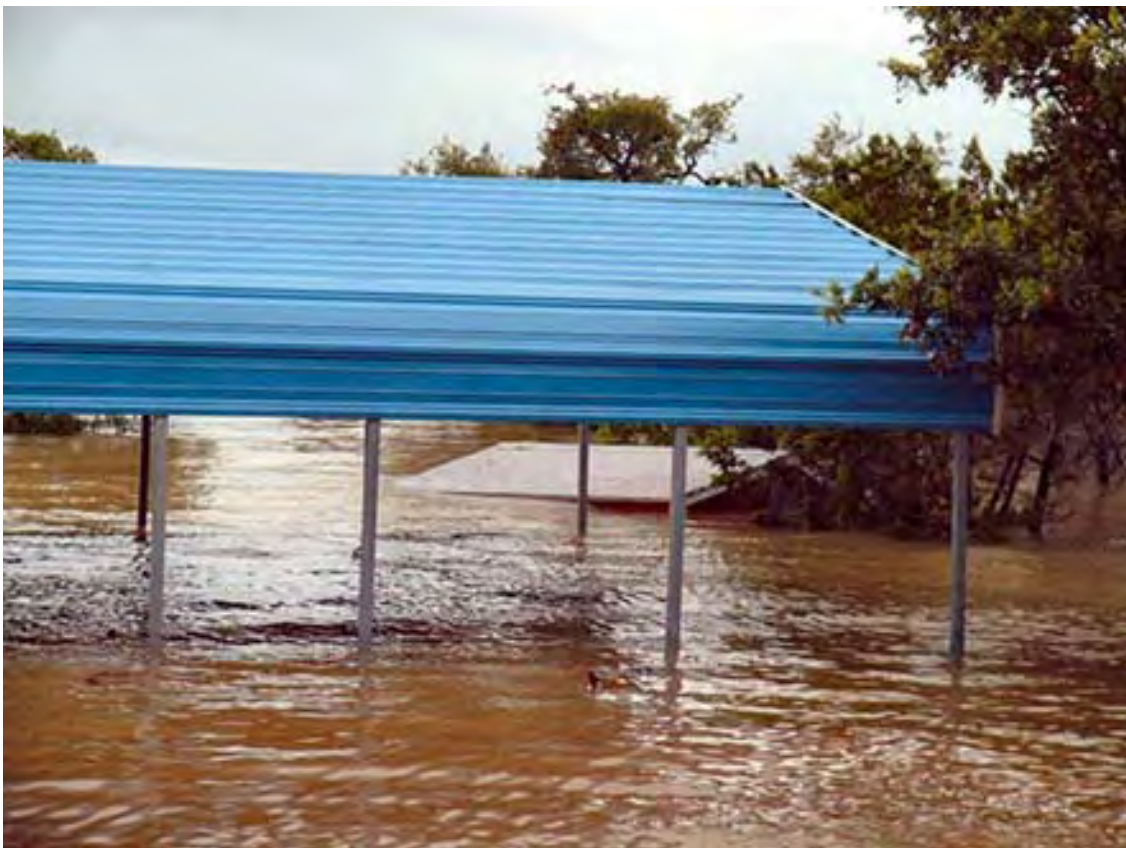
Fig. 1. Canyon Lake, Comal County, Texas 2002 Flood

Property damage from flooding is a persistent problem in Central Texas communities (figure 1). As development increases in the Texas Hill Country, the frequency of and costs related to flooding are projected to increase. Voluntary land buyouts have become popular in many communities to solve the problem of repetitively flooded areas. Since the Bunning-Bereuter-Blumenauer Flood Insurance Reform Act of 2004 (FIRA), there has been a move to require repetitive loss property owners to pay National Flood Insurance Program (NFIP) rates that reflect the actuarial risk associated with their properties. As land buyouts continue, larger areas of land adjacent to rivers will become community property and community leaders will need to make decisions regarding how to use this land. What to do with the voluntary buyout lands is a question of great importance for local communities.

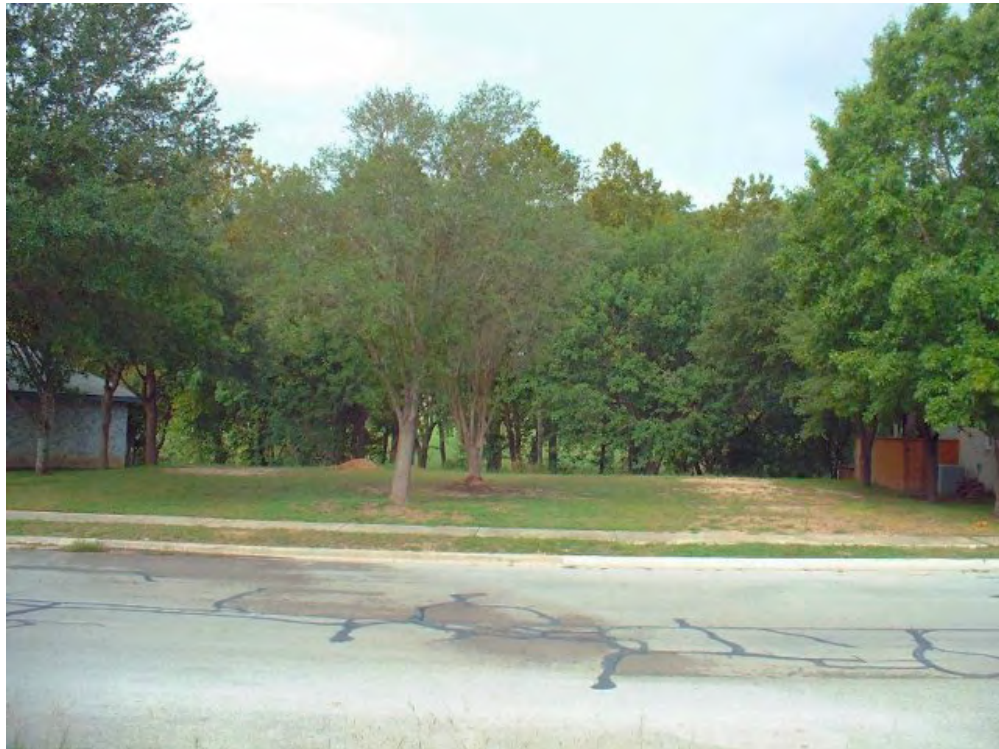
Fig. 8 633 Summerwood Property

after a buyout, so all properties have been cleared. Vegetation prior to the flood remains, except for what was scoured by flood and lost during the course of removal of the structures and slabs. Because of the residential landuse, most of the grass was Saint Augustine and there are still domestic shrubs such as ligustrum and red-tipped photinia (figure 8). Succession has occurred because very little has been done to the properties since the removal of the structures (figure 9). Herbaceous plants, vines, and woody plants have started to re-establish in some areas. There is debris consisting of pipes, pieces of concrete and asphalt, and various other materials still located on the properties. From site observations, it is assumed there are still underground pipes present and possibly buried septic tanks in the Sleepy Hollow area.

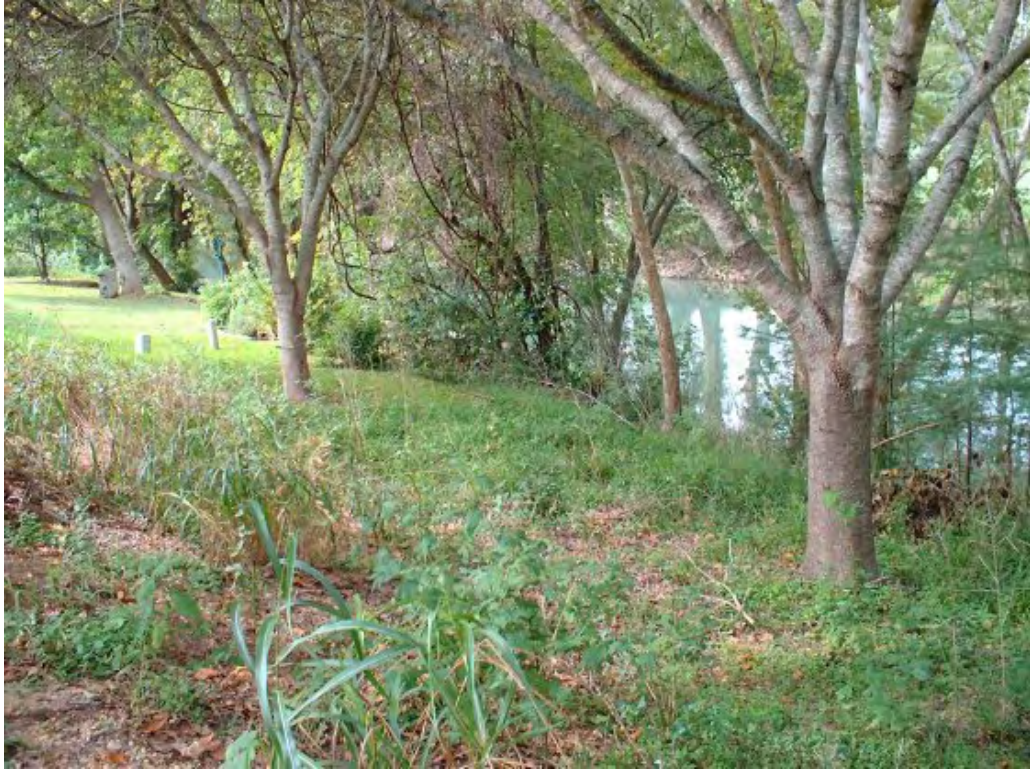
Fig. 9. Summerwood Succession

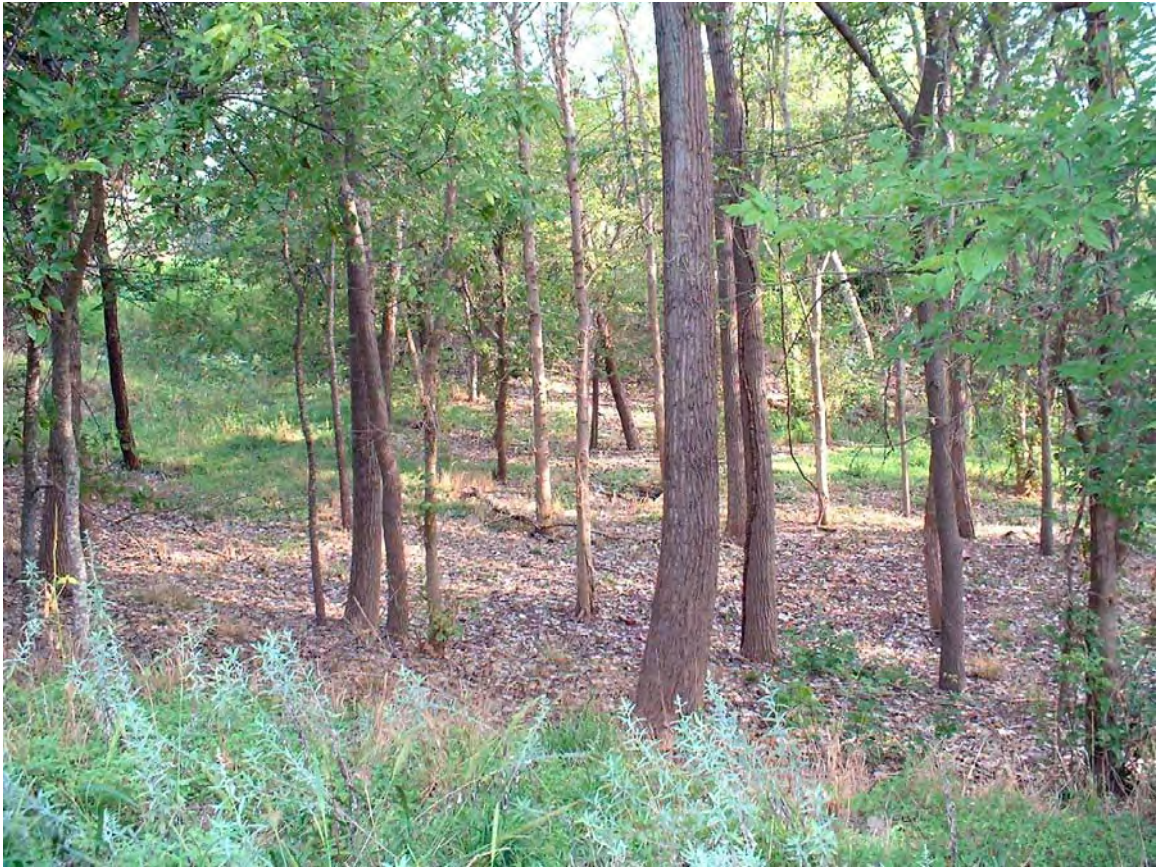
Fig.12. 1310 Sleepy Hollow

The property at 1310 Sleepy Hollow is the largest at 137,608 square feet (3.16 acres) (figure 12). It is the most amendable to restoration because it is already inhabited with native plants, and the size allows for more usage possibilities. It is a sink, a low-lying, poorly drained area where waters collect and sink into the ground or evaporates, with large trees and plants for wildlife cover and habitat. Site observation supported the idea that gravel may have been extracted from the site and formed the depression. Restoration entails cleanup of construction debris such as chunks of asphalt, pipes, and other materials; removal of non-natives such as Ligustrum, Chinese Tallow, and Chinaberry; and possible removal of an old septic system if present. Trails, picnic areas and wildlife observation sites could be implemented on this site because of the size.
