AN ANALYSIS OF CHANGES IN TEXAS WILD-RICE
DISTRIBUTION FOLLOWING THE 1998 FLOOD
OF THE SAN MARCOS RIVER, TEXAS

THESIS

Master of APPLIED GEOGRAPHY

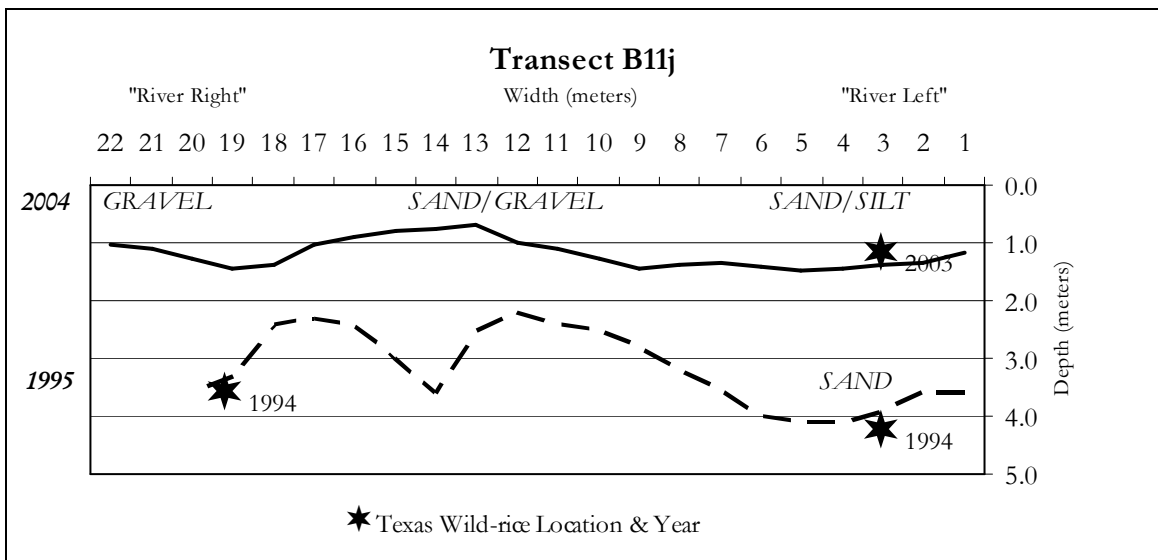
Figure 8 Transect B11j.

Transect B11j is located downstream of Sewell Park below Spring Lake and the confluence of Sessoms Creek. There has been an overall decrease in channel depth at this transect between 1995 and 2004. The mean depth was 3.15 meters in 1995 and aggraded to 1.09 meters in 2004. Both the left and right sides of the river changed approximately 2.5 meters. The decrease in the channel depth is due to sedimentation. Concurrent with the sedimentation, the composition of the bed substrate changed from 1995 to 2004. In 1995, the composition of substrate on the left side of the river near a wild-rice stand was sand, and in 2005, the substrate was sand and silt on the left, mid-channel was sand and the right side was gravel. The sand content of the bed sediments decreased by 19.2 percent, and the silt fraction increased by 31.2 percent. Simultaneous with these modifications in Transect B11j is the change in the size and distribution of wild-rice stands. In 1994, a Texas wild-rice stand was located on the right side of the river and by 2004, the stand of wild-rice had been removed. Additionally, in 1994, the wild-rice stand on the left side of the river was approximately 1.9 meters in width and 6.3 meters in length and in 2004 the wild-rice stand was 1.6 meters in width and 1.6 meters in length. Transect B11J is the furthest upstream transect to show a decrease in wild-rice.

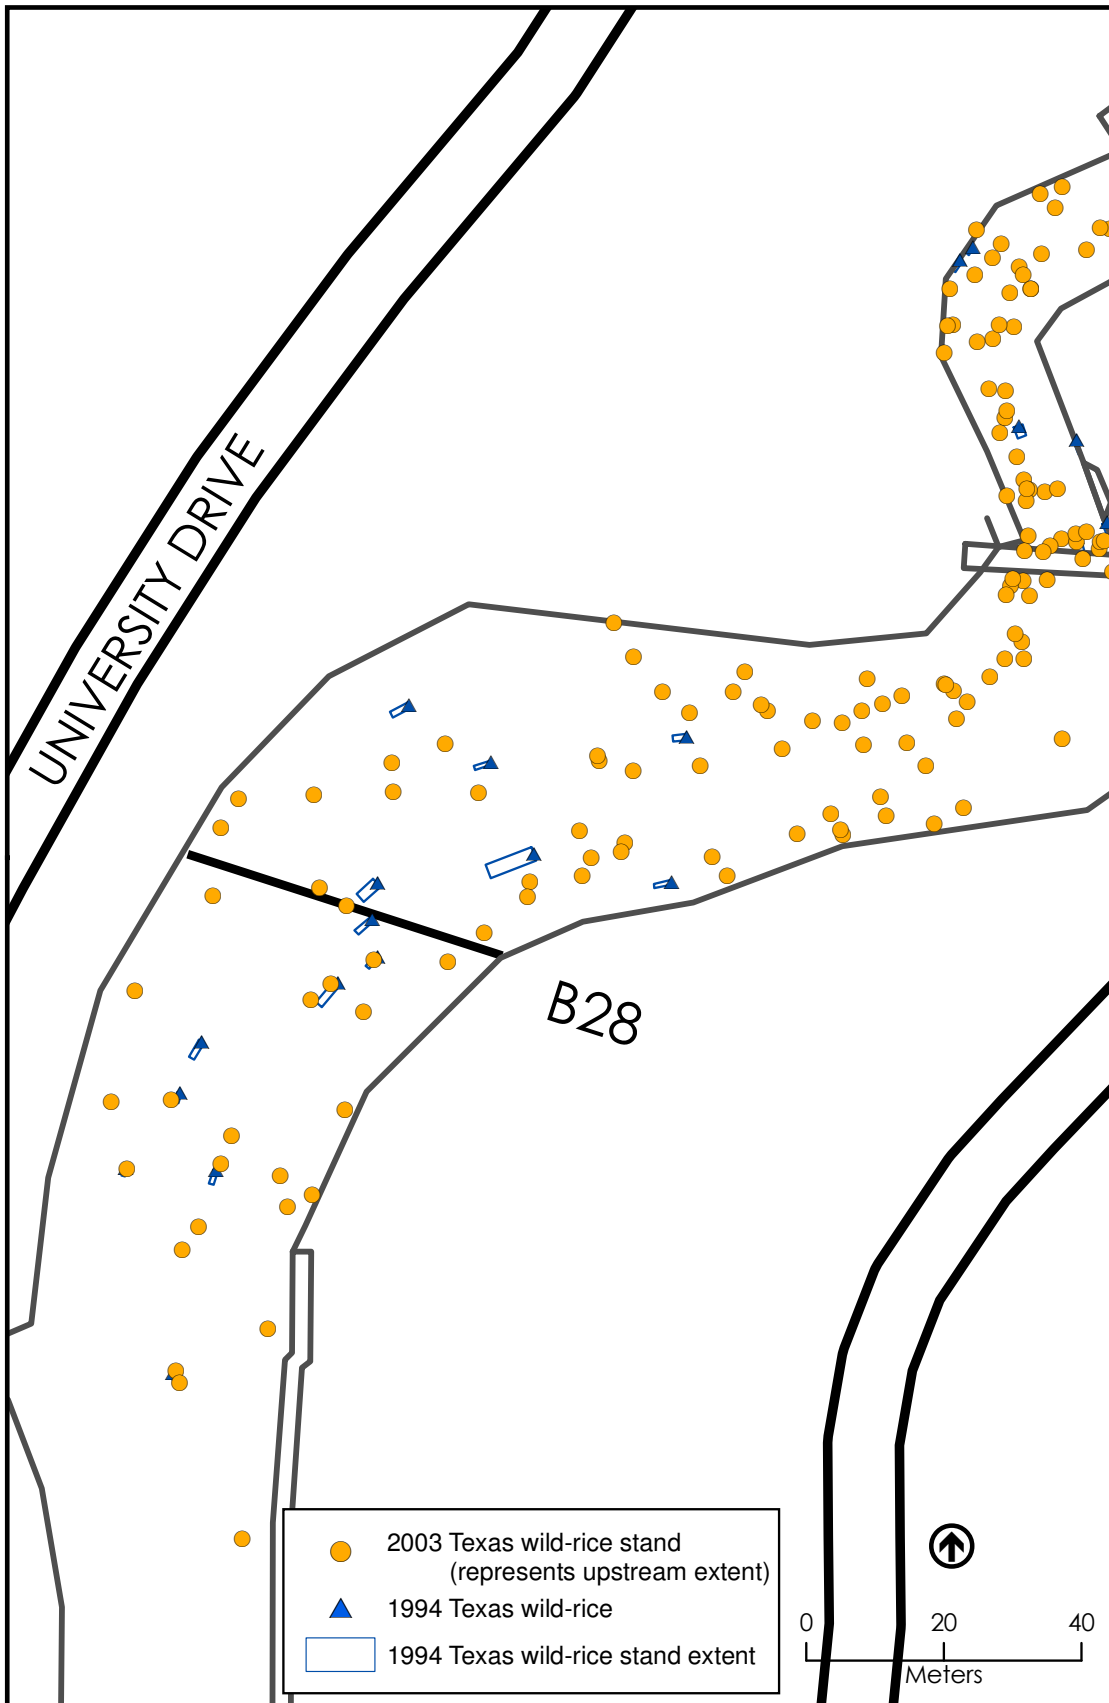
Figure 9. Map of Transect B28 Wild-rice.

Transect B28 is located in the northern section of City Park in the San Marcos River. There has been an overall decrease in channel depth at this transect between 1995 and 2004. The mean depth was 1.95 meters in 1995 and dropped to 0.86 meters in 2004. The right side of the river changed approximately 2 meters and the left side changed approximately 1.5 meters. The decrease in the channel depth is due to sedimentation. Concurrent with the sedimentation, the composition of the bed substrate changed from 1995 to 2004. In 1995 the composition of the substrate on the left side of the river near a wild-rice stand was sand and silt and in 2004, the substrate was gravel and sand on the left, mid-channel was gravel, and the right side was gravel. The sand content of the bed sediments increased by 15.2 percent, and the silt fraction increased by 12.8 percent. Simultaneous with these modifications in Transect B28 is the increase in the number and the expansion of Texas wild-rice stands into the newly shallow areas filled with sand and gravel. In 1994, a stand of wild rice was located on transect B28 at the middle of the channel. Several small stands were located on the left side of the river. In 2003, four new stands of wild-rice had become established near transect B28.

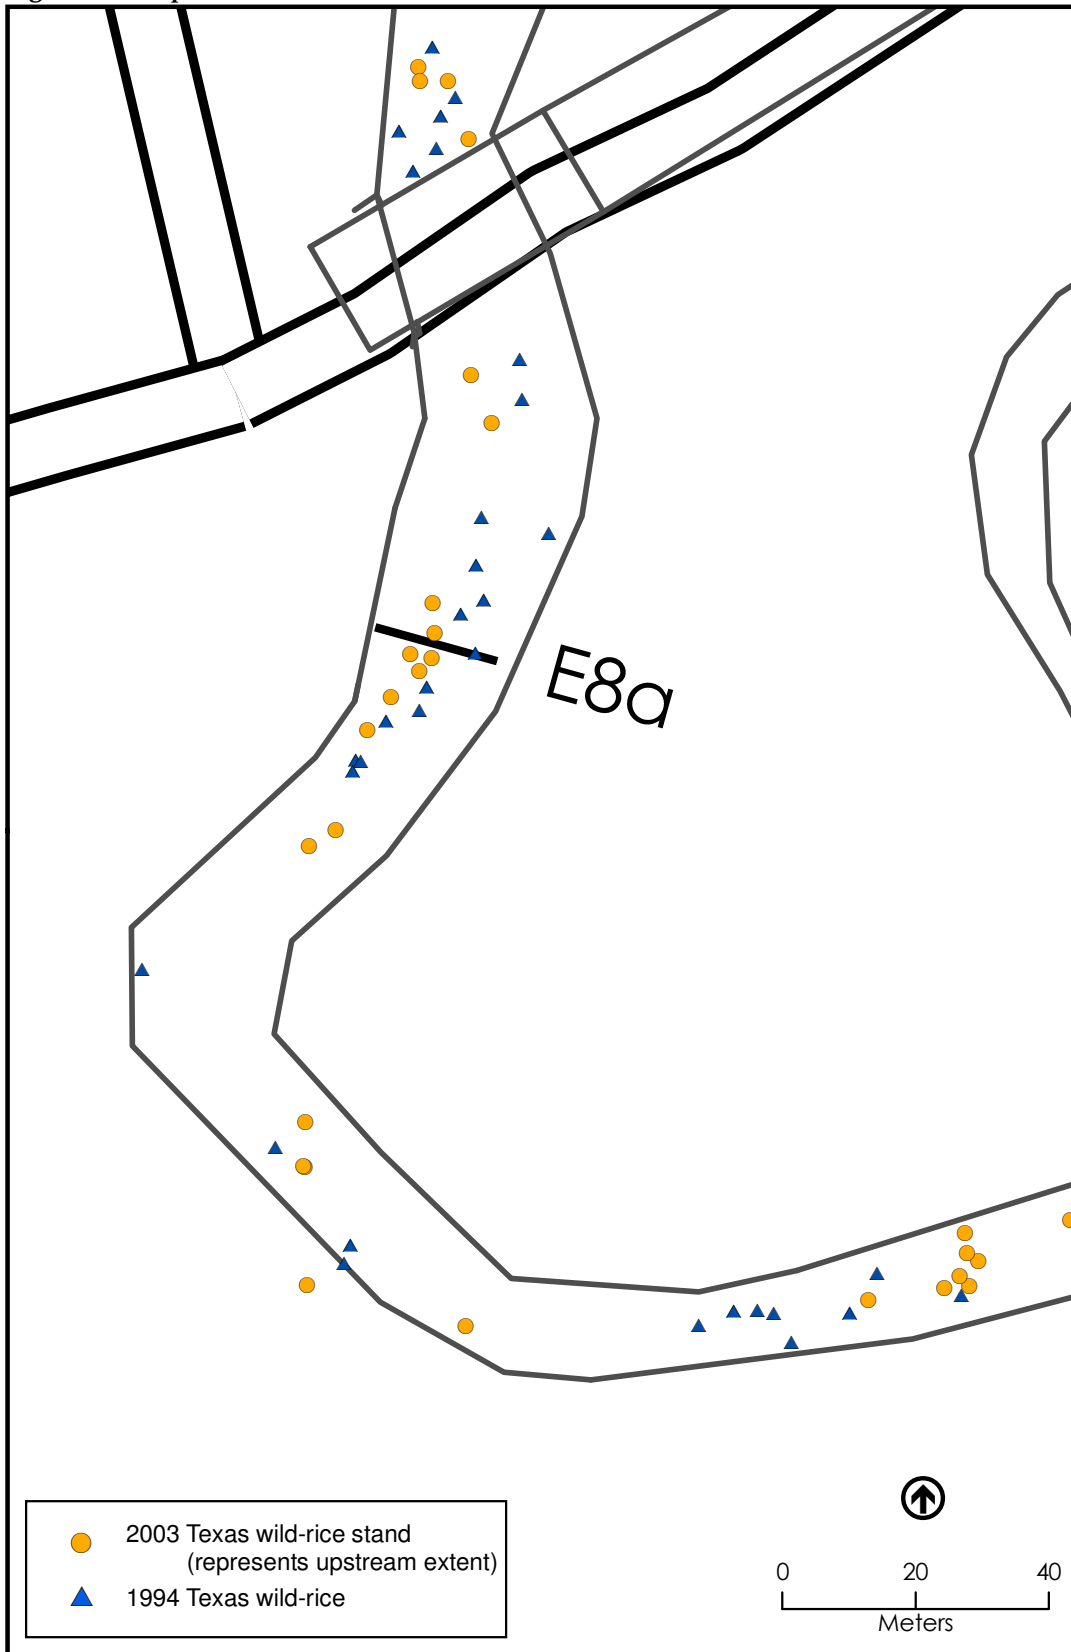
Figure 11. Map of Transect E8a Wild-rice.

Transect E8a is located in the San Marcos River below Rio Vista Dam and the Cheatham Street Bridge. There has been an overall decrease in channel depth at this location between 1995 and 2004. The mean depth was 1.64 meters in 1995 and dropped to 0.77 meters in 2004. The right side of the river changed approximately 1 meter and the left side of the river changed approximately 0.5 meters. The decrease in the channel depth is due to sedimentation. Concurrent with the sedimentation, the composition of the bed substrate changed from 1995 to 2004. In 1995 the composition of the substrate on the left side of the river near a wild-rice stand was sand and in 2004, the substrate was gravel and sand, mid channel was gravel, and the left side of the river was gravel. The sand content of the bed sediments decreased by 0.1 percent, and the silt fraction increased by 17.1 percent. Simultaneous with the modifications in Transect E8a is the increase in number of Texas wild-rice stands into the newly shallow areas filled with sand and gravel. One stand of wild-rice on the left side of the river which was present in 1994 was not present in 2003 and four new stands of wild-rice had become established near the middle of the river in 2003.

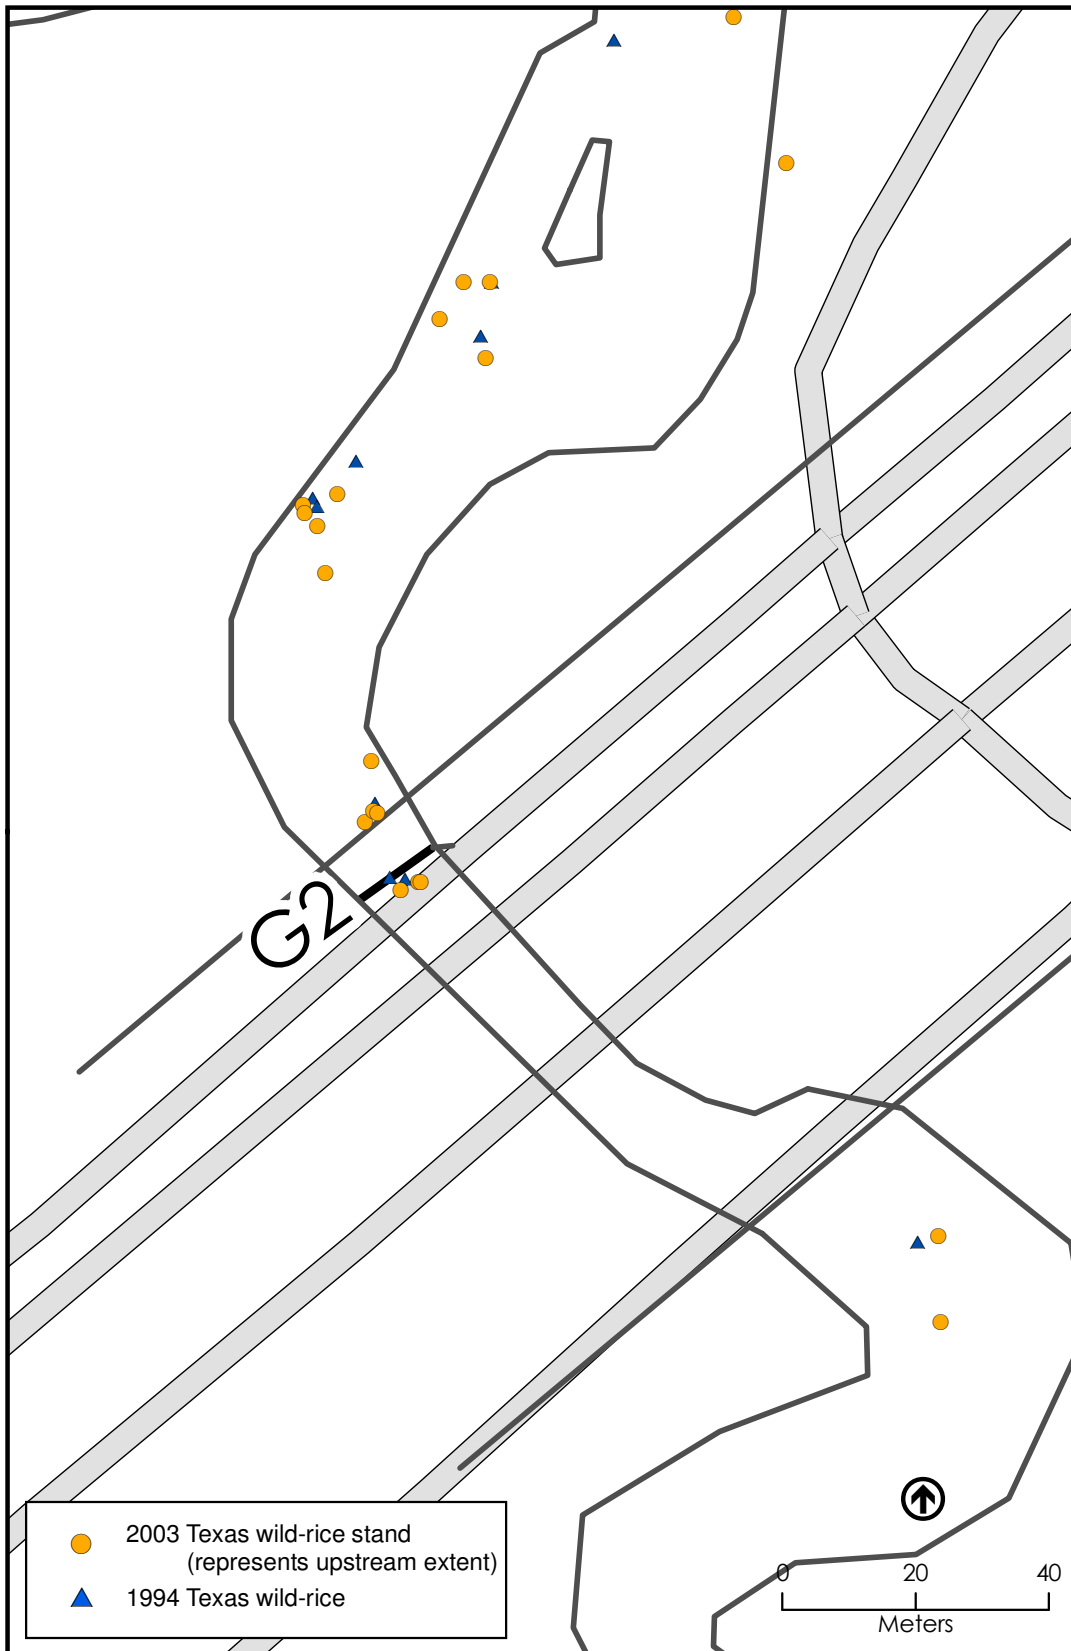
Figure 14. Map of Transect G2 Wild-rice.

Transect G2 is located in the San Marcos River directly below the Interstate 35 bridges. There has been an overall decrease in channel depth at this location between 1995 and 2004. The mean depth was 3.33 meters in 1995 and dropped to 0.94 meters in 2004. The decrease in the channel depth is due to sedimentation. Concurrent with the sedimentation, the composition of the bed substrate changed from 1994 to 2004. In 1995 the composition of the substrate on the right side and in the middle of the river was sand and in 2004, the substrate on the right side and in mid-channel was gravel, and the left side was sand. The sand content of the bed sediments decreased by 2.3 percent, and the silt fraction increased by 14.3 percent. Simultaneous with the modifications in Transect G2 is the removal of a stand of wild-rice in the middle of the river as the newly shallow areas filled in with gravel.
