**GEOSPATIAL ANALYSIS OF RIPARIAN CONDITION IN
LOCKHART, TEXAS: AN INVESTIGATION OF THE
INDEX OF RIPARIAN INTEGRITY**

A directed research report submitted to the Department of Geography and Environmental Studies at
Texas State University in partial fulfillment
of the requirements for the degree of
Master of Applied Geography
with a specialization in Resource & Environmental Studies

May 2023

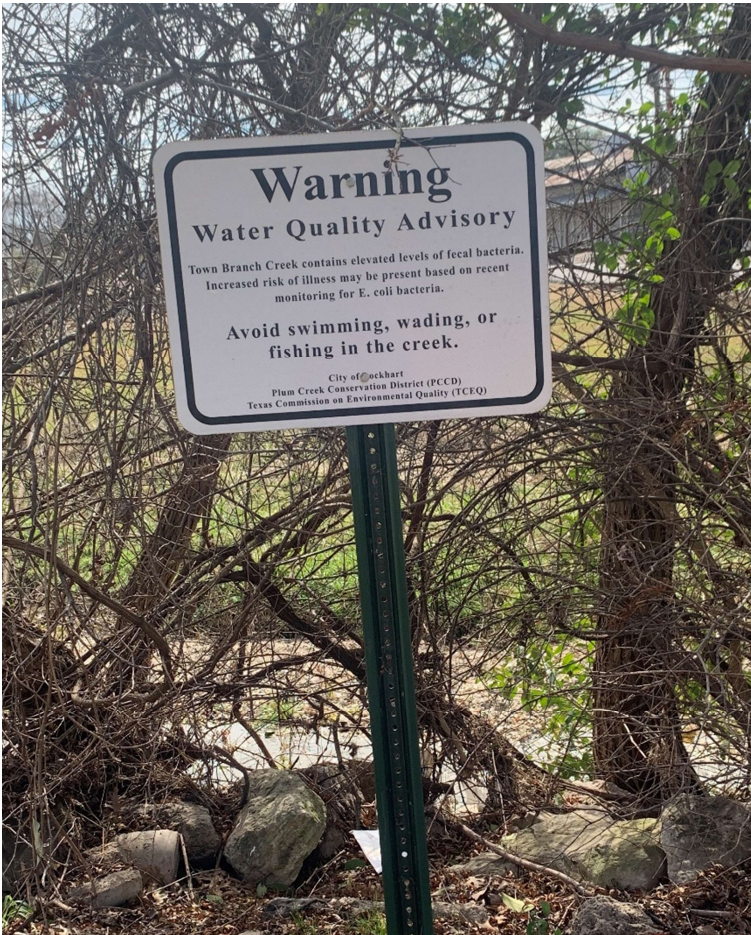
Figure 2. Sign posted along Town Branch warning of increased risk of illness due to increased fecal coliform bacteria.

phosphorus at all monitoring locations in Lockhart (Figure 2; Plum Creek Watershed Partnership, 2020).

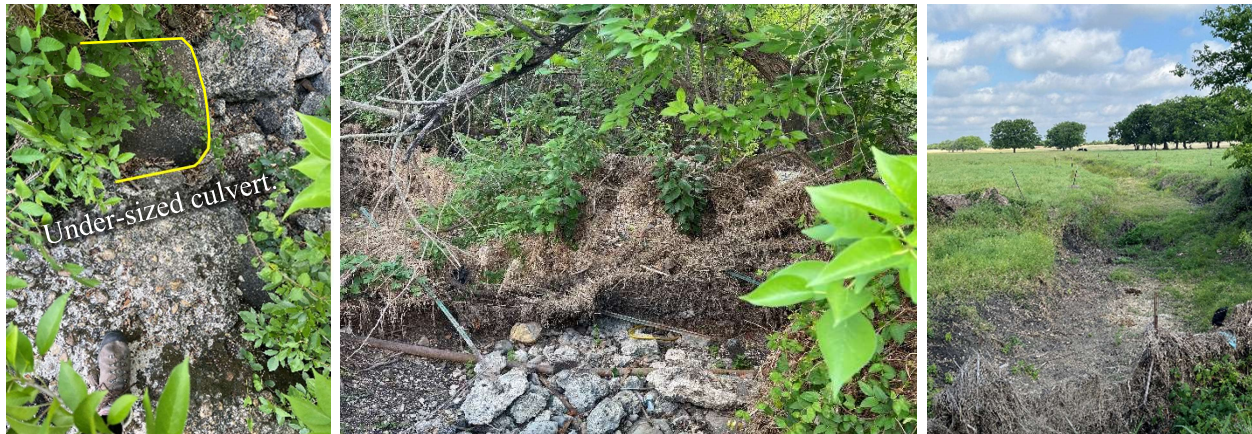
Figure 4. Under-sized culvert, debris caught in fence, and chute cut-off leading to off-channel pool at crossing at Stueve Lane.

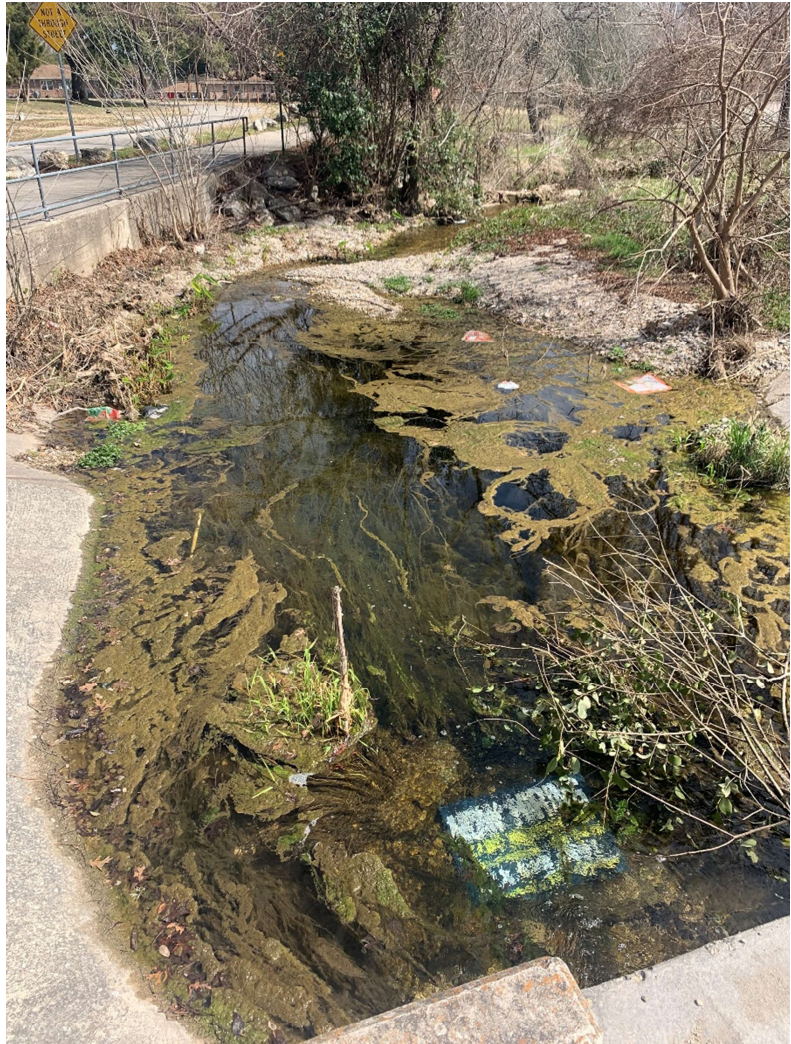
Figure 5. Algae, invasive plants, trash, and concrete-line channels result in impairments in Town Branch's Urban Trail Reach.

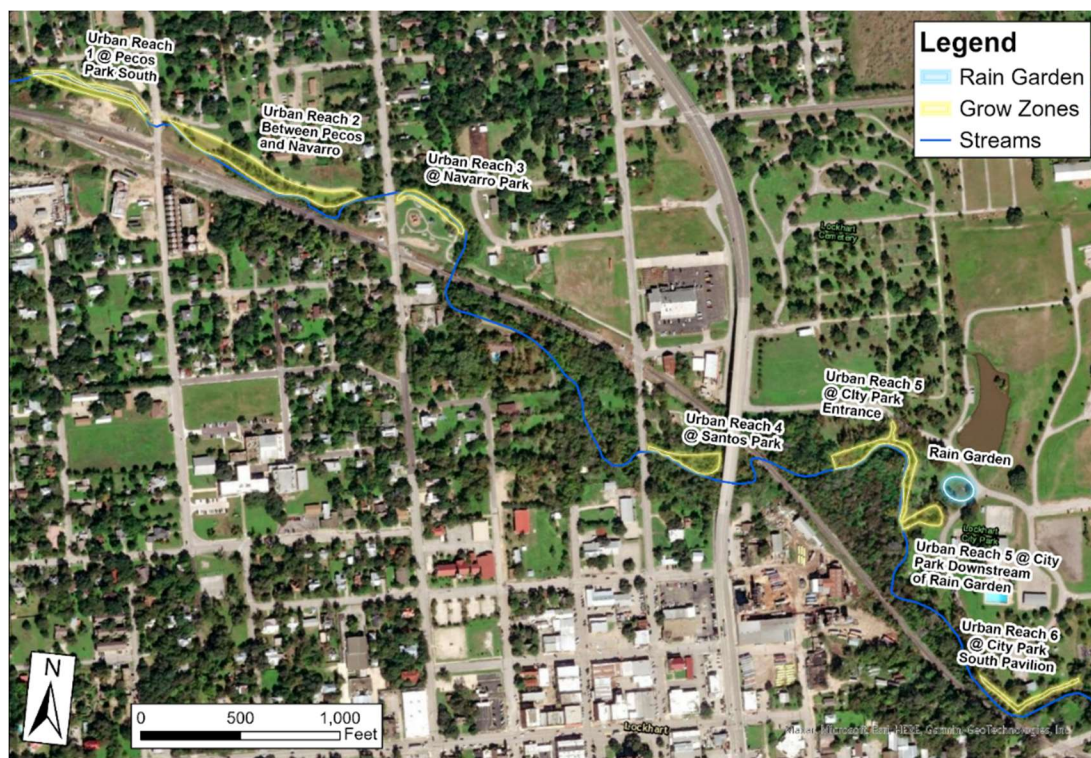
Figure 6. Map of the Town Branch Riparian Restoration Project area in Lockhart, TX.

Lockhart and Nueces River Authority, 2020a) and the establishment of six riparian best management practices known as grow zones along the Urban Trail and City Park reaches of Town Branch, totaling about 9,834 square meters (2.43 acres) (Figure 6; Figure 7; City of Lockhart and Nueces River Authority, 2020b). The purpose of these grow zones is to ameliorate effects of manicured and mowed residential landscapes, mowing too close to creek, and the artificial manipulation of the channel and its banks by establishing a mowing setback to restore and retain a buffer with natural vegetation to maintain a degree of riparian function. Eastern gamma grass (*Tripsacum dactyloides*) and switchgrass (*Panicum virgatum*) seedlings were planted in the grow zones because of their ability to withstand floods and promote stability (City of Lockhart and Nueces River Authority, 2020b).

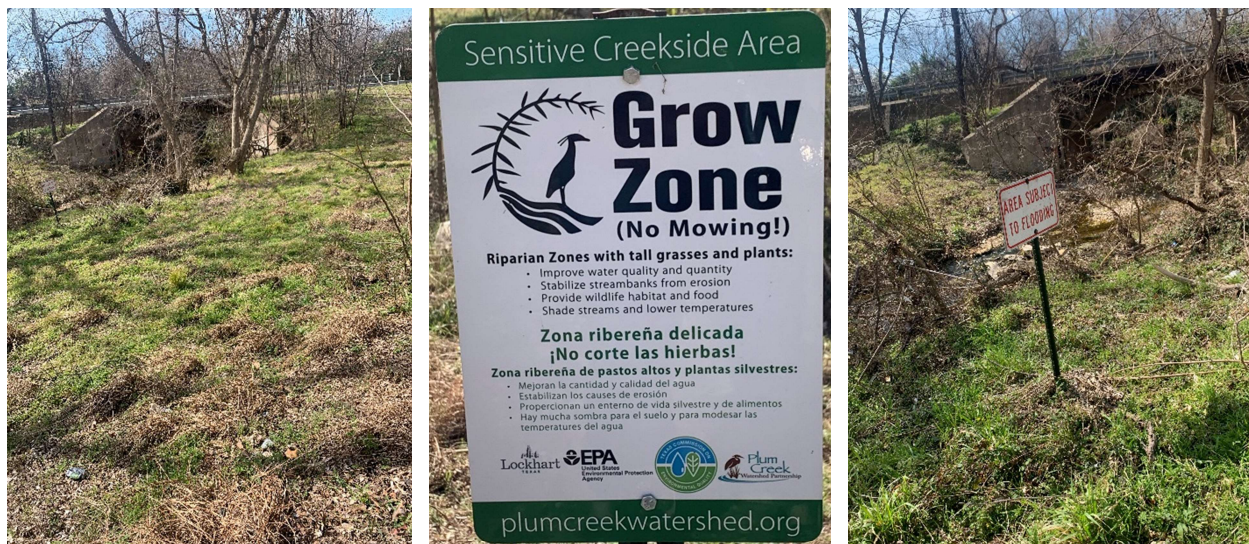
Figure 7. Urban Reach 4 at Santos Park grow zone (left, right) with signage posted at each grow zone area (middle).

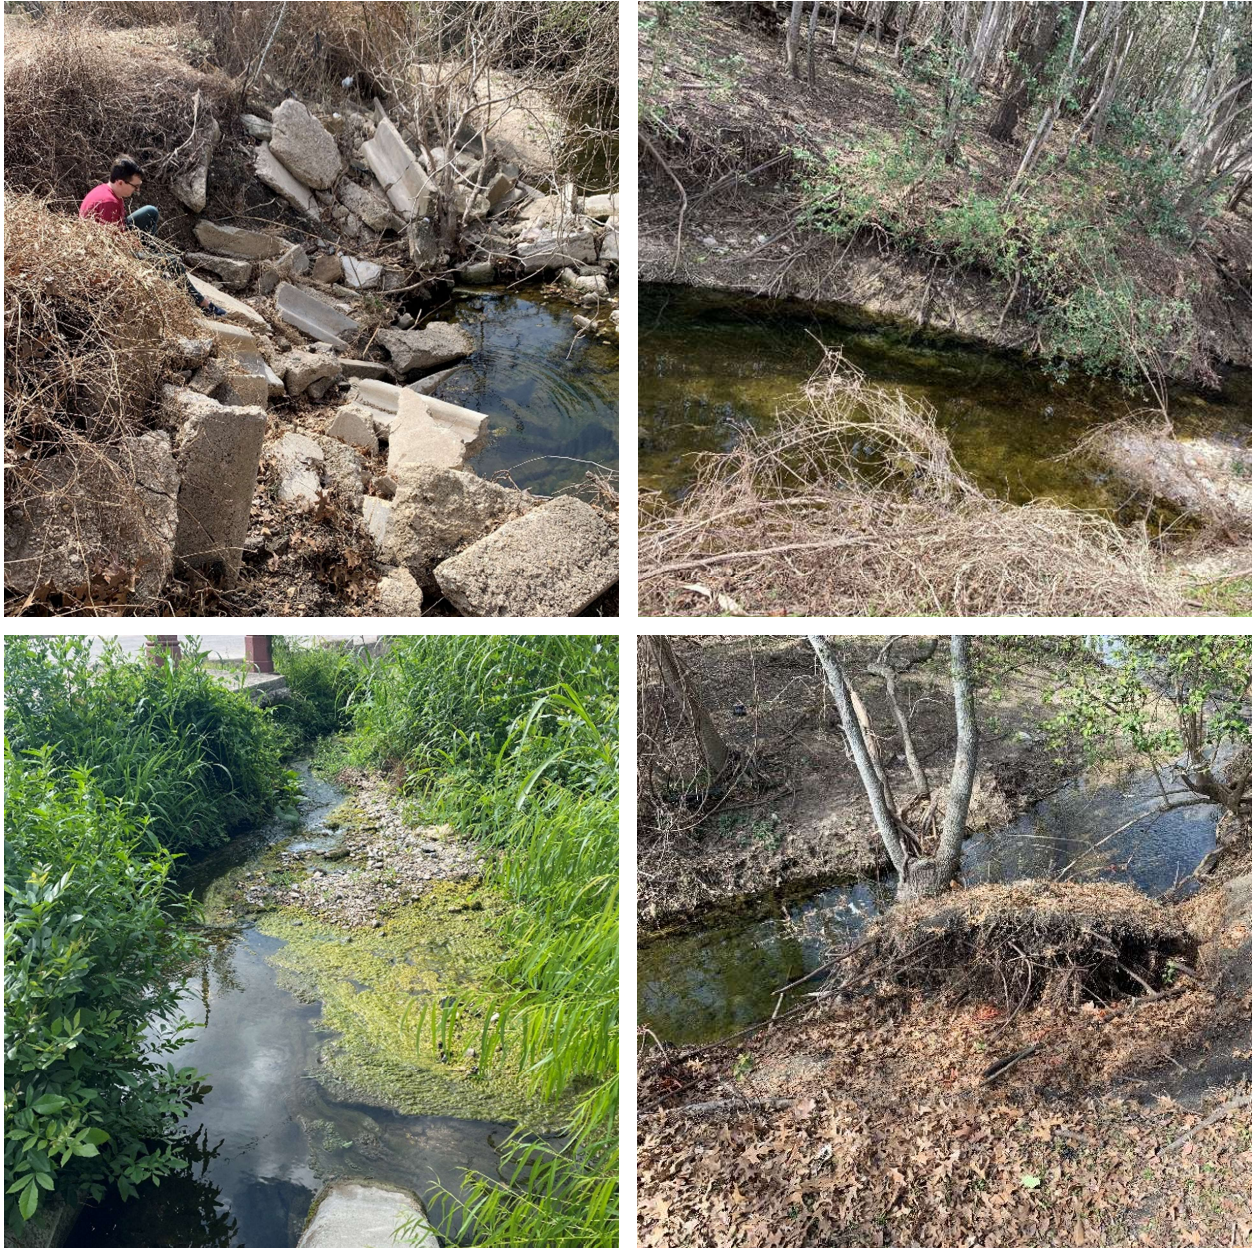
Figure 8. Examples of impairments characteristic “urban stream syndrome” (Walsh et al., 2005) throughout Town Branch.

Walsh et al. (2005) introduced the concept of the "urban stream syndrome" to describe the widespread systemic issues exhibited by many urban streams, including a flashier hydrograph, elevated concentrations of nutrients and contaminants, altered channel morphology and stability, reduced biotic richness with the increased dominance of more tolerant species, and

reduced baseflow and increased suspended sediment (Figure 8), both of which might not always be present.

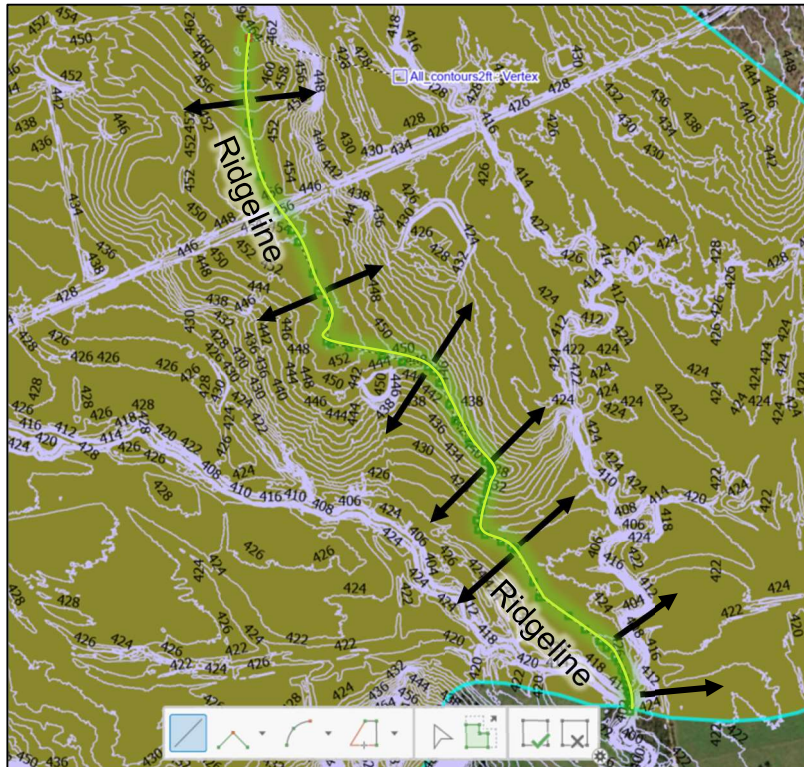
Figure 9. The process of delineating the Town Branch Watershed boundaries involved identifying and following ridgelines in the contours.

across the extent of the elevation dataset. Then, using this contour dataset, I edited the newly exported watershed file by identifying and following the ridgelines in the contours (Figure 9). This process gave me an accurate representation of the Town Branch Watershed boundary in which to perform analysis.
