Locating Tile Drains Using Historic Air Photos

Abstract

Key words: Historic air photos, drain tile, land-use, tile patterns

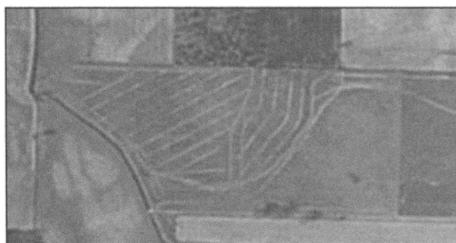
Figure 2. Example of herringbone and parallel tile placement, Allen County, Ohio, late October, 1956.

Two case studies were undertaken to illustrate the use of historic air photos to locate sub-surface drain tile. The first set of photos, taken in Allen County, Ohio, in late October, 1956, provide characteristic examples of tile pattern arrangements which can be used as a guide to determine the location of buried drain tiles. Figure 2 depicts a combined herringbone and parallel pattern of tile placement. Figure 3 is an example of parallel and random mixed placement while Figure 4 exhibits a mixture of herringbone and parallel patterns. The crisp appearing edges on the 1956 photos suggest that the installation was completed a short time prior to the aerial photo.

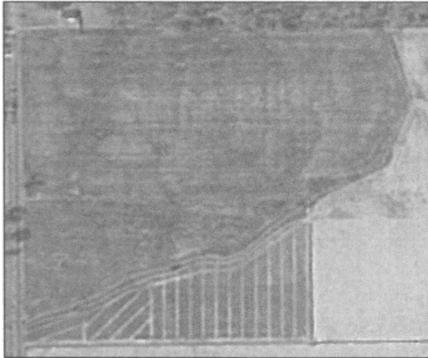
Figure 4. Example of mixed herringbone and parallel tile patterns in Allen County, Ohio, late October, 1956.

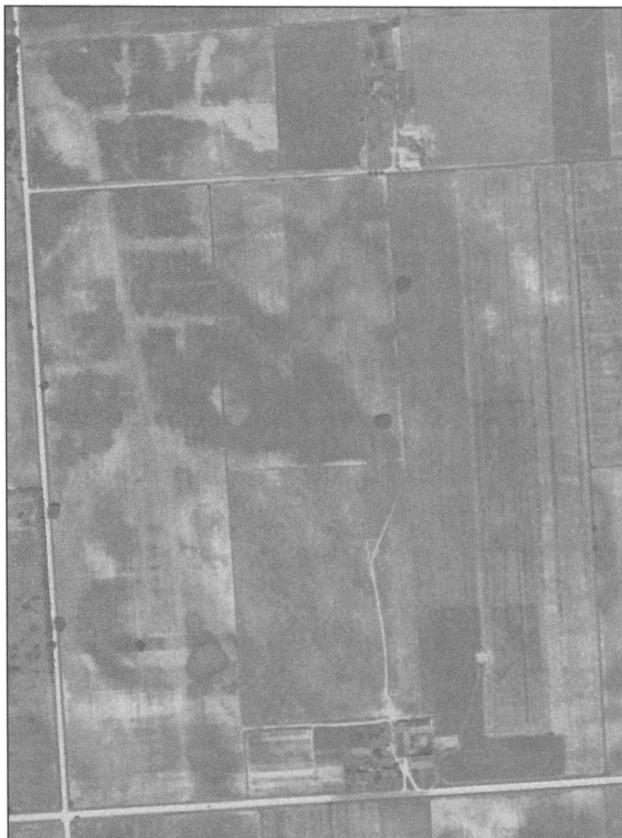
Figure 5. Example of random tile placement pattern in Montgomery County, Ohio, July 1938.

or more in the two to three days before the photographs were taken enhances the contrast between tile lines and the surrounding landscape enabling more accurate identification. In the case of the following photos, the 1938 photos were taken shortly after an event of between 0.23 and 0.28 inches of rain prior the acquisition of the photography precipitation. Air photo interpreters beginning an investigation for tile drains should access the historical weather statistics for the area in question prior to searching for photography in order to enhance the chance of success.

Taken in Montgomery County, Ohio, in July, 1938, Figure 5 depicts a random pattern and Figure 6 shows parallel patterns. While the tonal and geometric patterns are evident in the 1938 photos, the blurring of the edges suggests that there was a more extensive passage of time between tile installation and photo acquisition than in the 1956 photos. This combination of geometric pattern and tonal differences provides the interpreter with guides to the location of the tile lines.

County soil surveys can also be of assistance in locating tile drained fields. Figures 5 and 6 are both Brookston silty clay loam soils whose description indicates a need for drainage.
