A HISTORICAL INVESTIGATION OF MORPHOLOGICAL CHANGE IN THE
RIO GRANDE CHANNEL BELOW BROWNSVILLE IN RESPONSE
TO UPSTREAM HYDROLOGIC CONTROL INITIATIVES

THESIS

Yvonne Rita Setser, B.A.

San Marcos, Texas
December, 2000

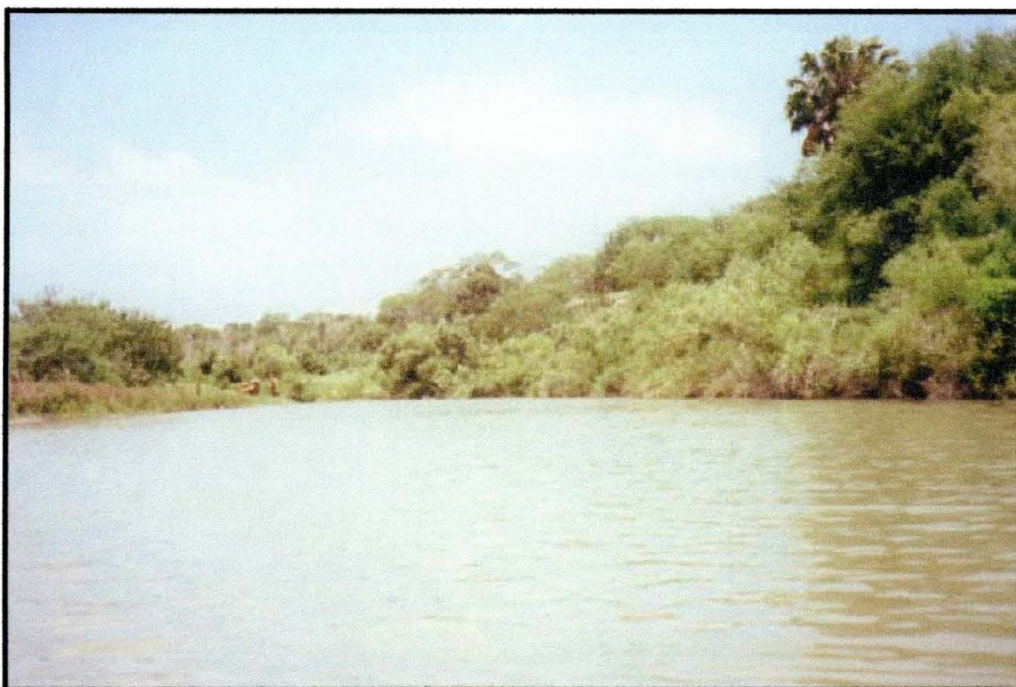
Fig. 5. Photograph of the Rio Grande downstream of Brownsville, Texas

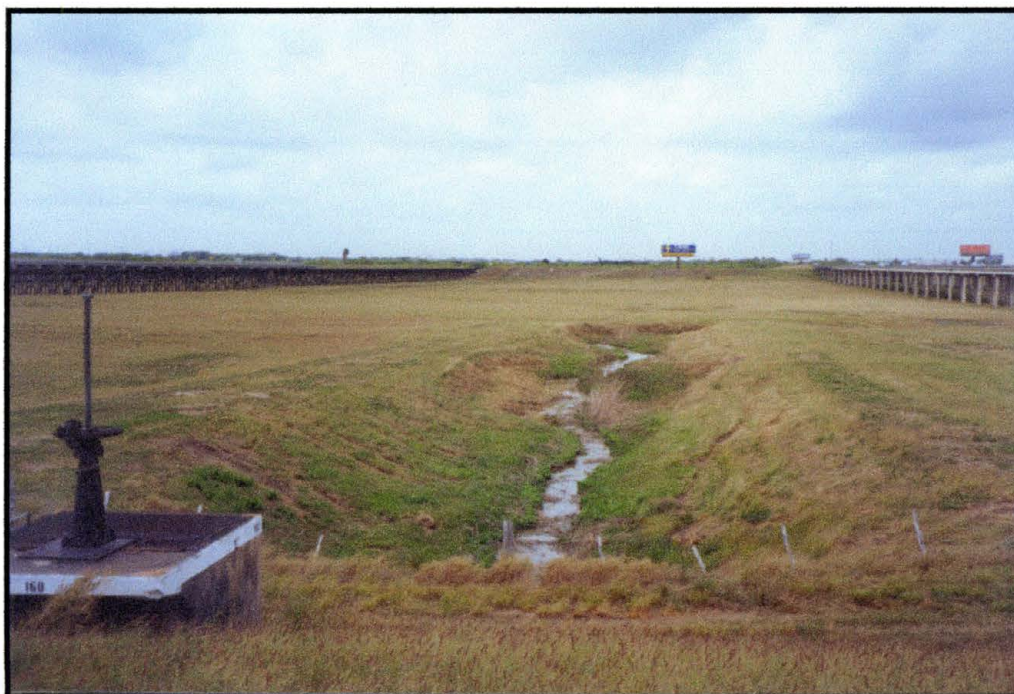
Fig. 6. Photograph of the Main Floodway near Mercedes, Texas
