FOULED BALLAST AND GEOTECHNICAL ASSET
MANAGEMENT OF RETAINING WALLS

A thesis submitted to the Graduate Council of
Texas State University in partial fulfillment
of the requirements for the degree of
Master of Science
with a Major in Engineering
December 2022

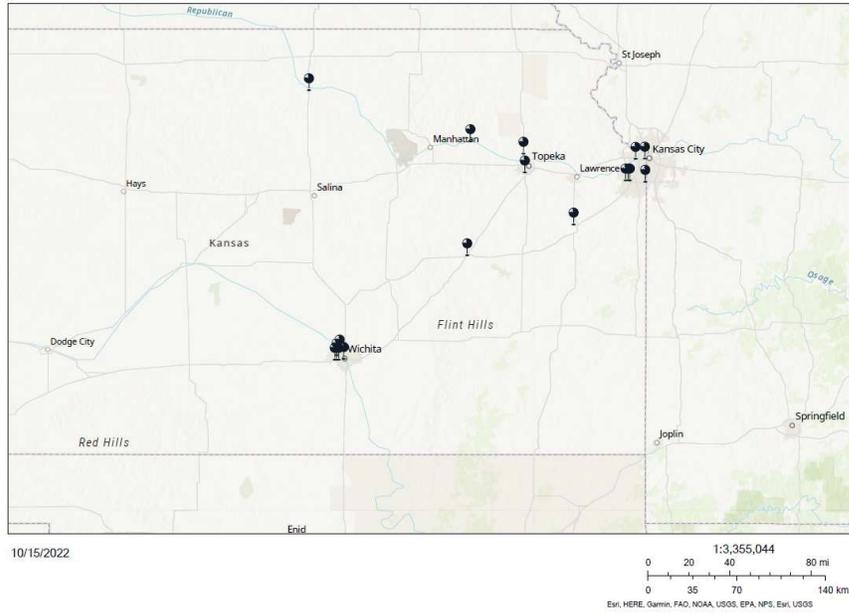
Figure 4-14 Location of MSE Walls Inventoried

The nineteen walls selected by KDOT are shown in Figure 4-14. Many of the walls are still in good to fair condition. Figure 4-15 is a comparison of the nineteen walls with and without the AHP method. The comparison shows on average a 0.1 increase in performance of the MSE wall when the AHP method is applied. This was expected since Gerber (2012) had vegetation rated the least impactful to the overall rating of an MSE wall.

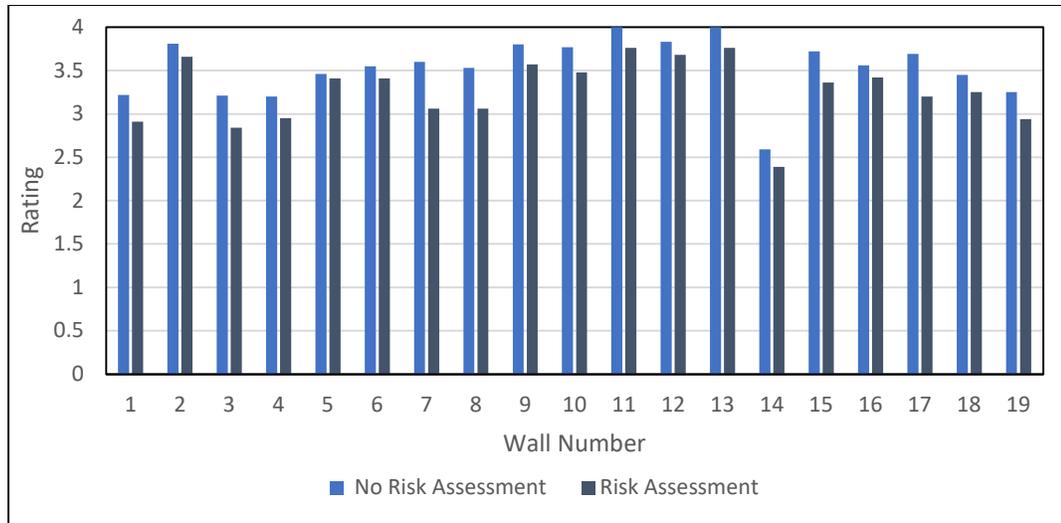
Figure 4-16 Initial Inspection of KDOT MSE Walls

The risk assessment that was added based onto the inspection checklist included height, age and AADT (Tarawneh, Al Bodour, & Masada, 2018). On average this risk assessment decreased the wall rating by of 0.2. This was expected because most of the walls are in either high traffic areas, % are older than 20 years and some are very tall. Typically, a rating of 0.96 was applied to each of the modifying factors.
