EVALUATION OF THE EFFECT OF MICROBIAL ACID ATTACK ON CONCRETE
BRIDGES IN TEXAS

THESIS

by
Luzelva Estrada, B.S. Biology

San Marcos, Texas
December 2011

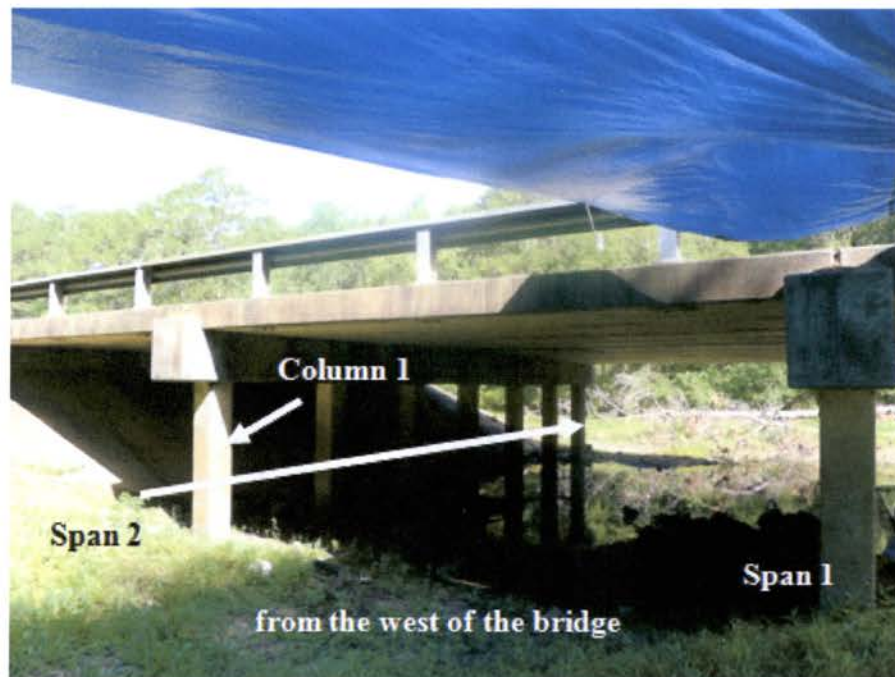
Figure 2: Column and span naming convention for FM 787 at Tarkington Bayou (Liberty County)

The first bridge is located on FM 787 at Tarkington Bayou (Liberty County). The overall bridge site has low deterioration. Two water samples were obtained with one underneath the bridge and the second 100 yards upstream from the bridge. Concrete scrapings were taken on three different columns at various elevations from the ground. On the first column samples were taken at 6 inches and 22 inches from the ground; the second column, a sample was taken at 20 inches; and on the third column, a sample was taken at zero inches from the ground. This bridge site was later revisited and two water samples were collected, one near the bridge and the second upstream from the bridge. A mud sample was also collected near the bridge. Concrete scrapings were obtained from wall 1 and column 1 at various elevations from the ground. The first set of concrete scrapings was obtained from bridge 1 span wall 1 at 6, 18, and 42 inches from the ground. The second set of concrete scrapings was obtained from bridge 1 span 1 column 1 at 6, 18, and 42 inches from the ground. Figure 2 shows a picture taken from the west side of the bridge, there are two spans labeled 1 and 2. Each span consists of a row of seven columns. Columns were identified from the north to south and spans were identified from the west to east. Samples from other bridge locations following the same identification convention mentioned above. All surface core samples were obtained by TxDot personnel. Core samples were extracted from Tarkington Bayou, Navasota River, Lake Tawakoni, and Alligator Bayou using a HILTI DD 120 Diamond Coring System with 1.5 inch core bit. The first set of cores obtained from the initial visit at Tarkington Bayou was extracted from the southwest end of a 1970's concrete precast limestone

aggregate column at 6 and 22 inches from the ground. The second set of cores was extracted from a 1970's west end expansion site cast wall at 20, 27, and 34 inches from the ground. The third set of cores was extracted from a 1930's west end middle span section concrete column taken at 21, 28, and 38 inches from the ground. The final set of cores was taken from a 1970's precast limestone aggregate on the southwest side of the column at 10, 14, and 26 inches from the ground. Samples collected from the 1970's concrete were extended based on the original bridge which was built in 1930's. Table 1 summarizes sampling and bridge site information.
