# MECHANISMS OF PROCESSING-RELATED DEFECTS IN PMR-15/CARBON COMPOSITE MATERIAL LAMINATES

## THESIS

James E. McBride

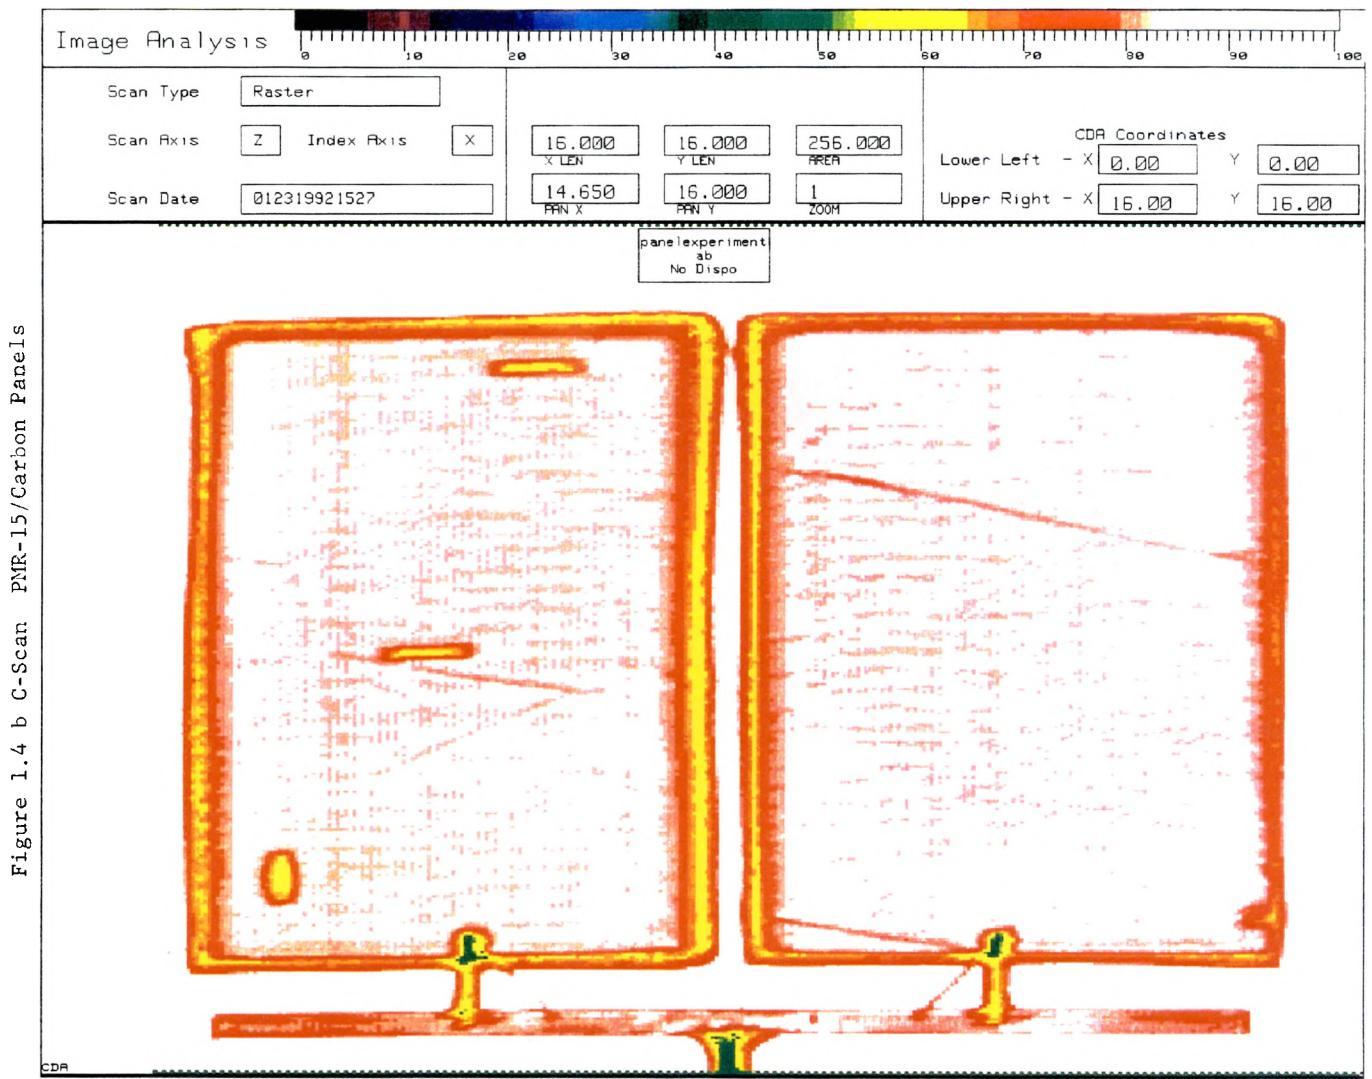
An example of a C-Scan sonogram is given in fig. 1.4b. This is a sonogram of two PMR-15/Carbon panels mounted on a t-shaped holder at the bottom of the figure. The sonogram reveals a color display of the specimen under consideration. The color designations have great significance in the interpretation of the figure. Note the colored scale at the top of fig. 1.4b which displays the numbers 0 to 100 above which are the color designations that pertain to those numbers. The numbers represent the percent transmission of the original signal strength through the specimen depending on how the system

is calibrated. The colors above the percent transmission scale are the respective colors on the sonogram. In other words, the green areas in fig. 1.4b represent a signal recovery by the receiving transducer of between 39 and 51 percent of the transmitting transducer's original signal.

The major percentage of figure 1.4b is represented by the red to pink regions of the transmission scale. This implies that through the majority of the panels good sound transmission was achieved. Also note the three distinct yellow regions on the left panel. These areas indicate poor transmission of sound through the specimen as denoted by the transmission scale. From this indication, one can surmise the presence of discontinuities in the materials under analysis.

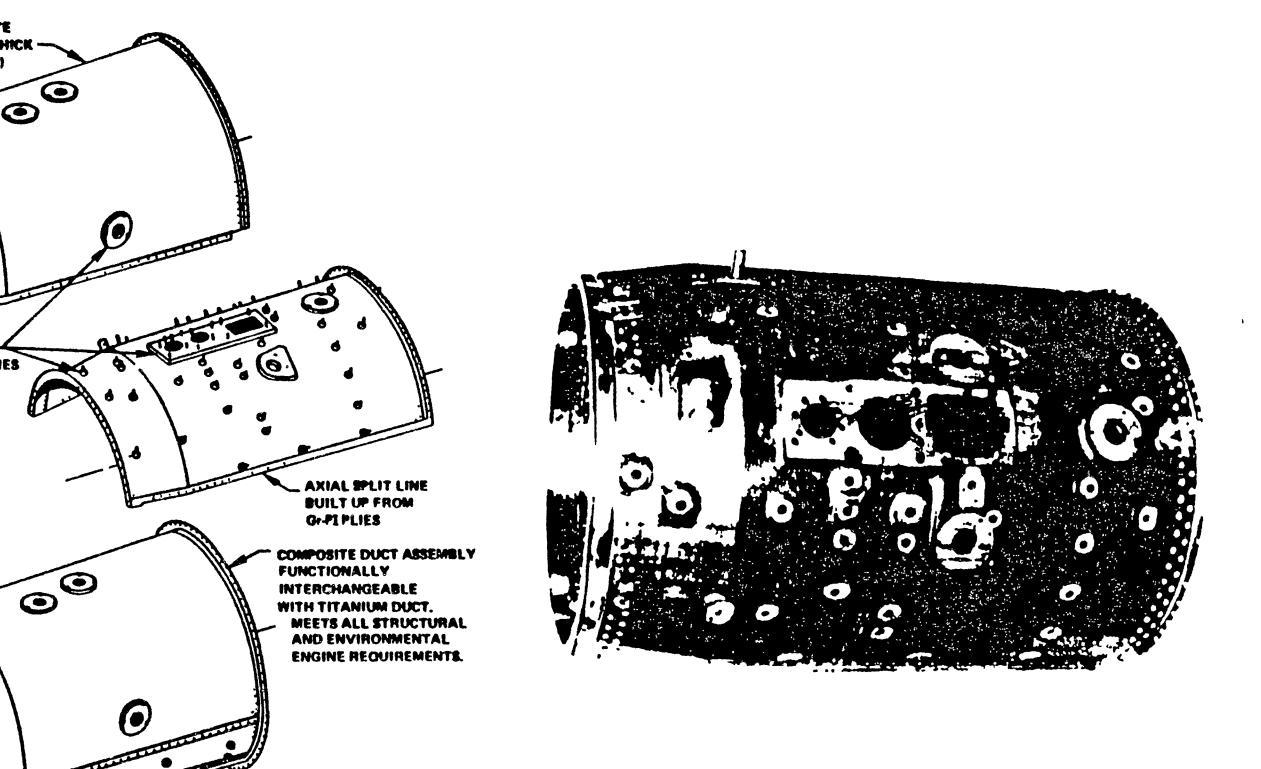
Voids in a PMR-15/Carbon engine duct tend to coalesce near differing ply buildups. To elaborate, the duct thickness varies because there are a different number of plies in certain areas of the duct from other areas. The areas of differing thickness are located where the boss plys are situated. Figure 2.1a illustrates an engine duct structure where the bosses are clearly marked.[3] When this duct is molded, the boss plies are located in a recessed portion of the mold. These portions of the mold are also the locations of the vacuum port attachments on the mold. If the boss plies are not completely compressed or purged of air in the recessed areas, this may initiate ideal conditions for void growth. For this reason, it is very important to make sure that the prepreg laminate is fully purged in these areas of the mold before autoclave curing.

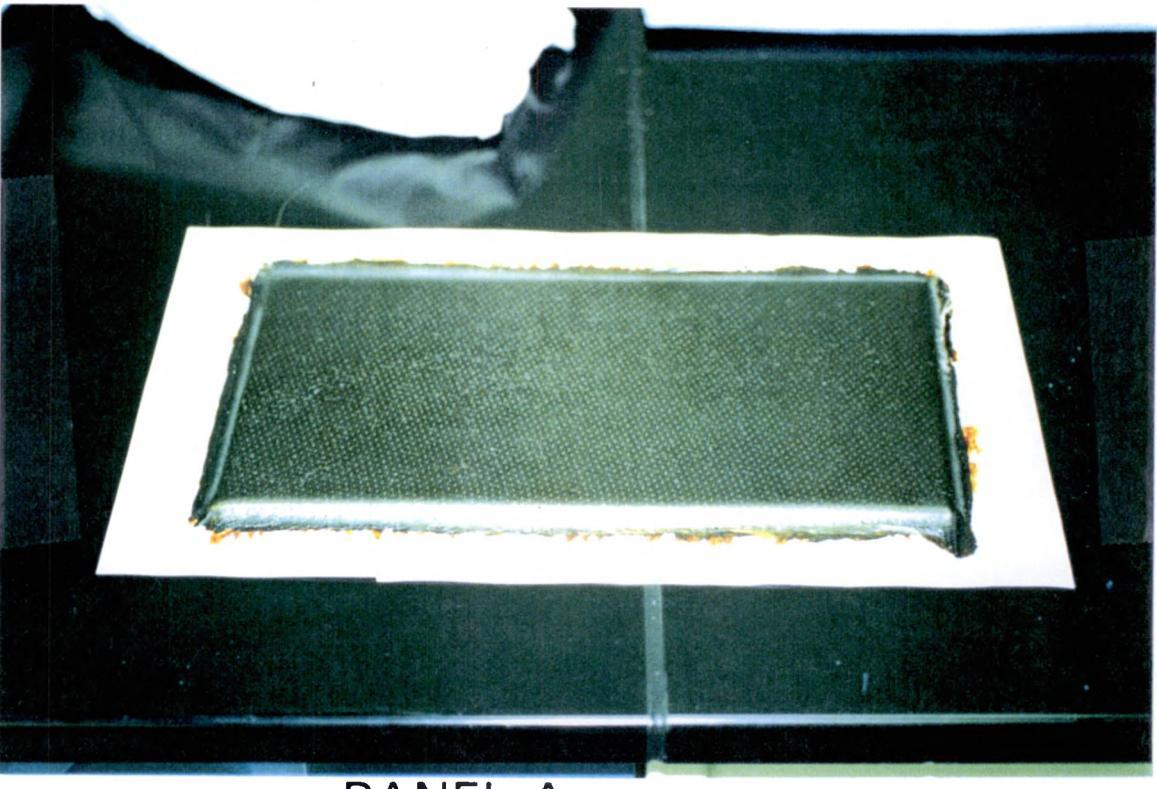
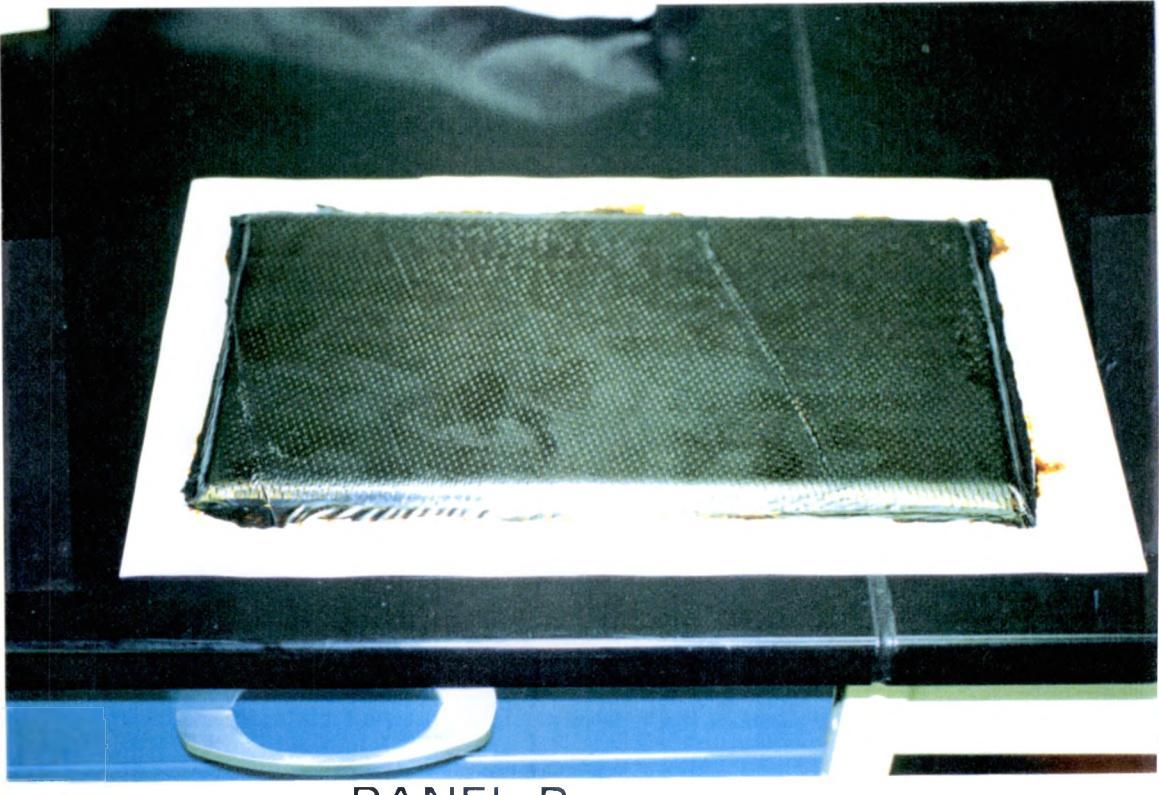
Figure 2.2a is a photograph of the panels taken while they were still enclosed in the vacuum bag on the mold surface. The vacuum bag is represented by the gold colored plastic sheet covering the mold surface. The results of the visual analysis indicated that panel A (Left side of fig. 2.2a(i)/Right side of fig 2.2a(ii)) did lose some of its resin when a full vacuum was applied to the bag over the mold. This is illustrated in fig. 2.2a by the black dots on the surface of the breather cloth.

Panel B (Right side of fig. 2.2a(i)/Left side of fig. 2.2a(ii)) however, which was not properly ventilated, revealed that the resin sought to escape from under the non-perforated resin barrier. This is illustrated by the presence of the black edges of panel B and the "Crow feet" lines at the corners in fig. 2.2a. Panel B also retained 2.3% more of its original prepreg weight because of poor exhaustion of its volatile contents and the inability of the resin to escape through the breather cloth. Upon visual inspection of the panel surfaces outside of the bag, it was noted that panel A (Figure 2.2a(i)) had a rough surface contour and panel B (Figure 2.2(ii)) had a smoother surface. Each panel had notable creases across their width. The creases could have been caused by virtue of the fact that panel A was under a compaction force of over 15,000 lbs. and panel B, a force of over 15,000 lbs. during a pressure application in the autoclave.

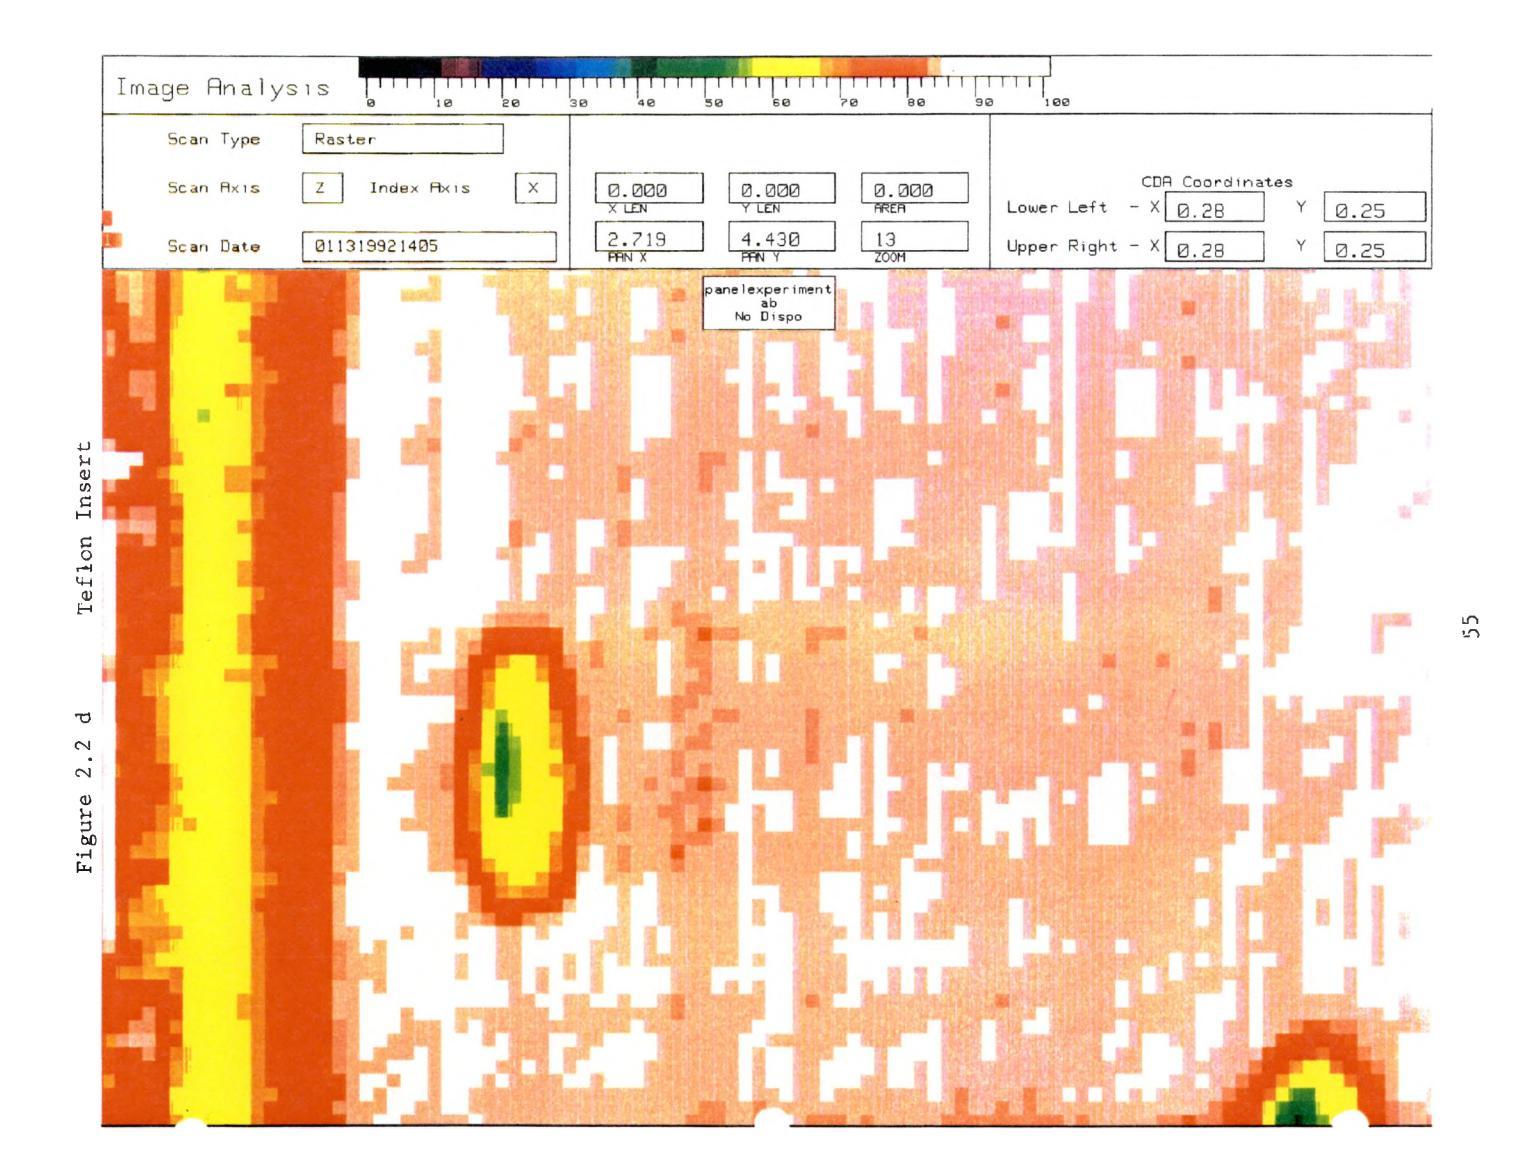
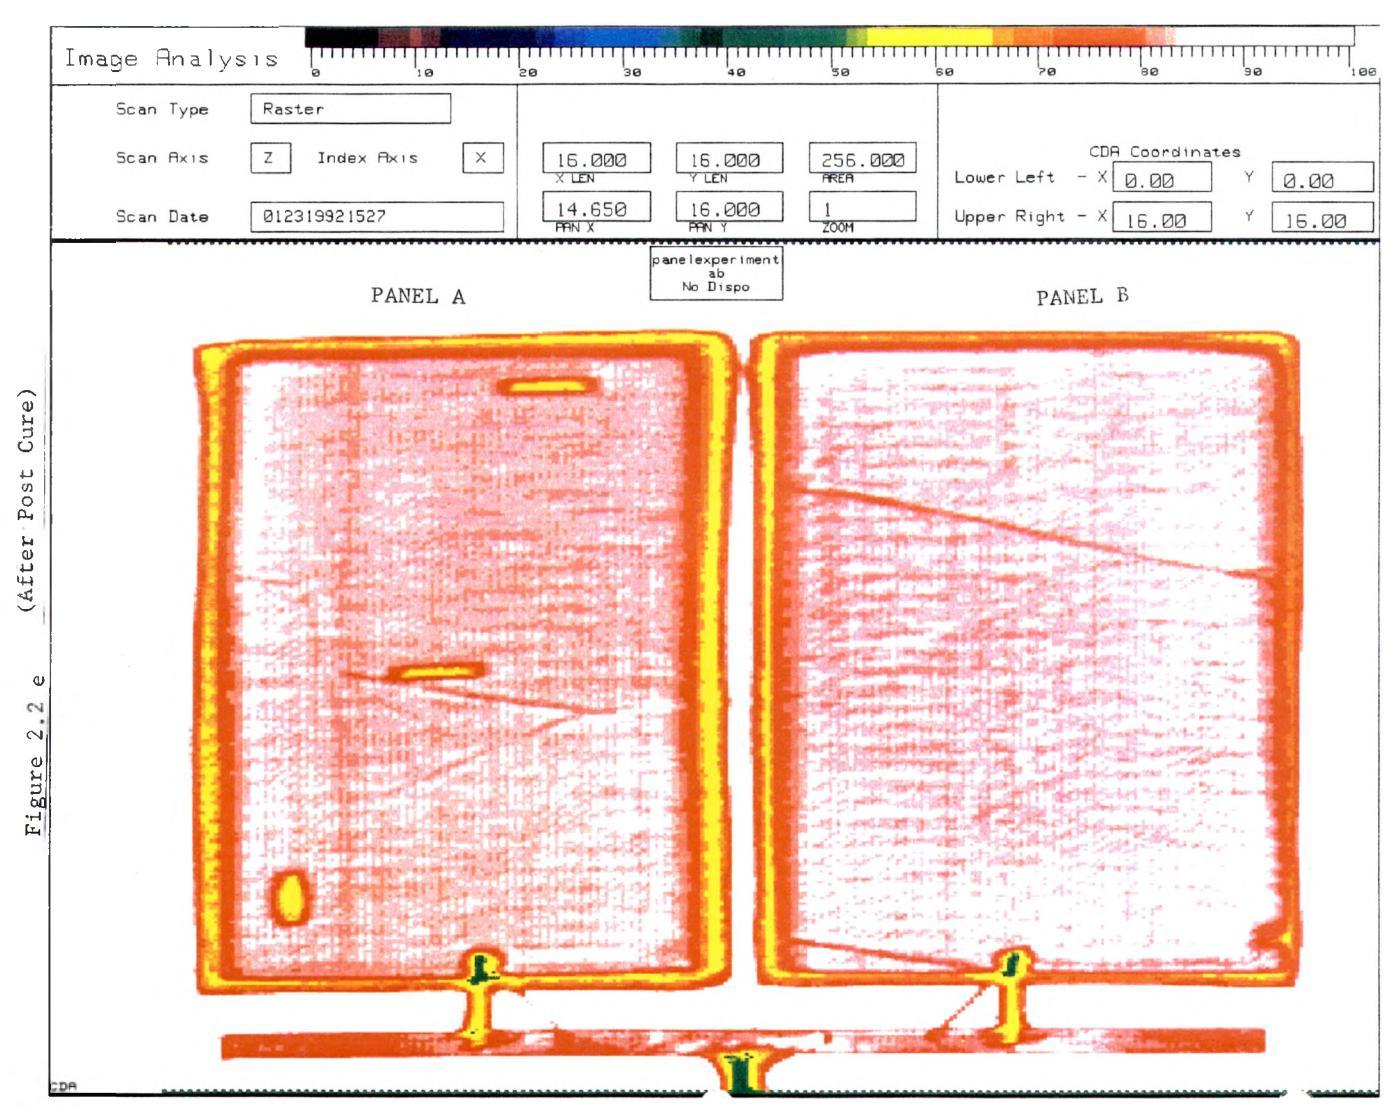
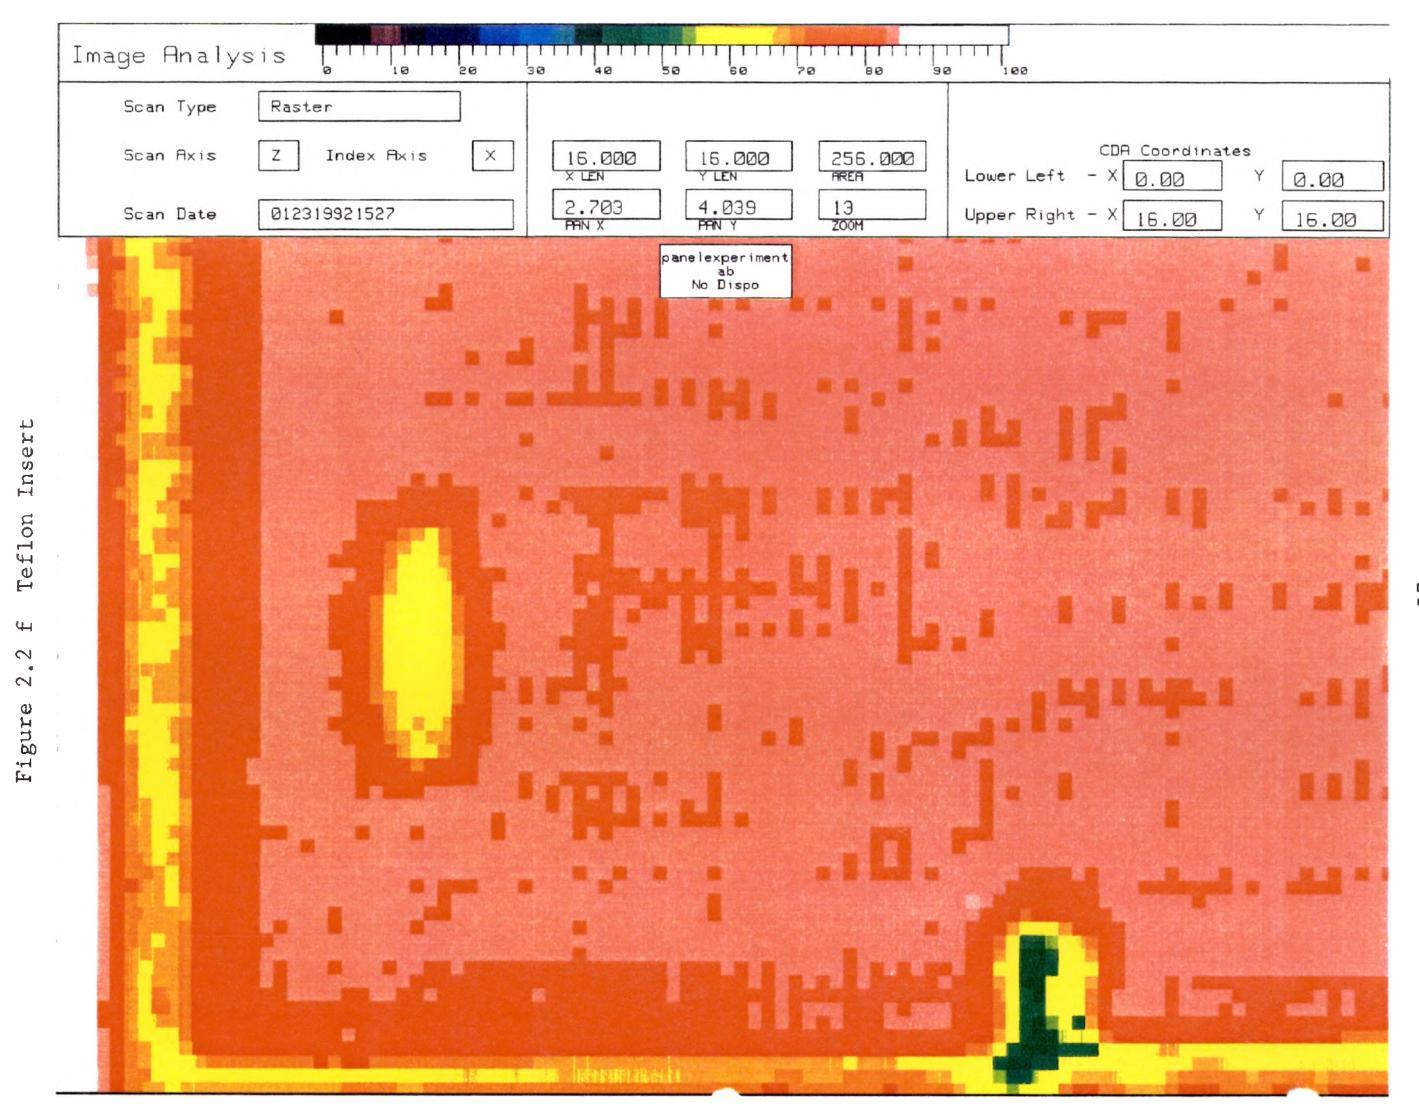
The C - Scan image in fig. 2.2c shows the panels following the autoclave cure, prior to the post cure. This figure indicates that laminate A was fully consolidated except for the areas in which the material inserts were placed. The brass insert is at the top right of the C-Scan, the graphite insert is in the middle and the teflon insert is at the bottom left of fig. 2.2c. From fig. 2.2c, it can also be noted that the teflon insert appeared to have expanded during the autoclave cure which can be accounted for by the fact that teflon will cold flow under pressure. A closeup C-Scan of the teflon insert is pictured in fig. 2.2d from which it appears that the center of the insert is more dense as a result of the green color. The center of the insert could have become more dense as

After post - curing, the panels were inspected by the same means once again. Visual observation revealed nothing more unusual about the exterior of the laminates. The second ultrasonic C-Scan picture in fig. 2.2e appeared identical to the first other than a slight difference in the teflon insert region (Panel A) which could be attributed to the thermal properties of a thermoplastic polymer. To elaborate, the illustration in fig 1.1a demonstrates that the mechanical properties of thermoplastic polymers change as a result of a temperature increase. Consider the subjection of Panel A to the heat of the postcure oven. The long heating soaks of the postcure could conceivably reorient the molecular structure of the teflon insert. The change of molecular structure might allow the insert to obtain a more uniform density instead of having a greater central density (Recall the central green region of fig. 2.2d.). It is clear that the teflon insert must have endured a physical change by

inspecting figures 2.2d and 2.2f. The uniform density of the insert would then reduce the attenuation of the ultrasonic sound beam.
